# Macassa Mine Battery Fires Summary

February 15, 2024

The following presentation will detail a summary of battery fires experienced at our Macassa operation.

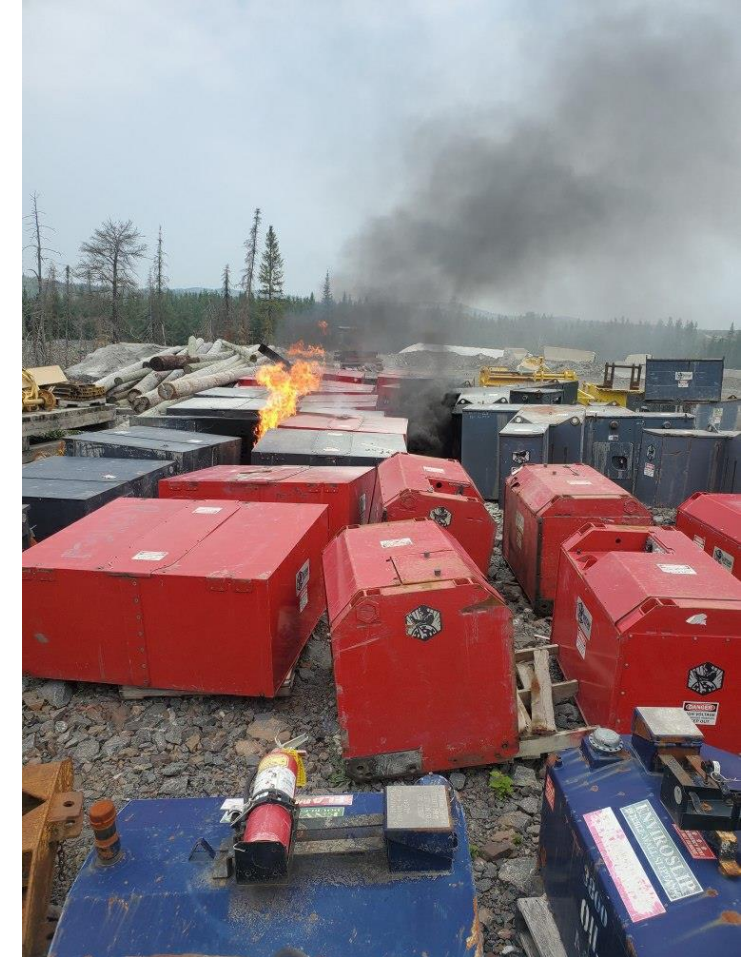
At 11:35 am on 30 June 2023, a Mechanic was passing past the surface battery storage area and noticed smoke emanating from a decommissioned Artisan battery pack BZ007 (used in Z40/50 underground haulage trucks). Shortly after, the flame could also be seen. They immediately notified his supervisor, who notified Site Security. The mechanic, along with another, attempted to extinguish the flame using handheld ABC extinguishers (5 in total), this was initially successful. The local fire department was called. The mechanics began to separate the batteries using a front-end loader to give the fire department room to work and prevent other batteries from being affected, while doing so, the affected battery reignited. The fire department arrived on site and doused the battery with water and then foam, extinguishing the fire.

The investigation revealed that there were isolation faults between the modules within the battery pack that shorted through the frame igniting the internal flammable components of the battery pack.

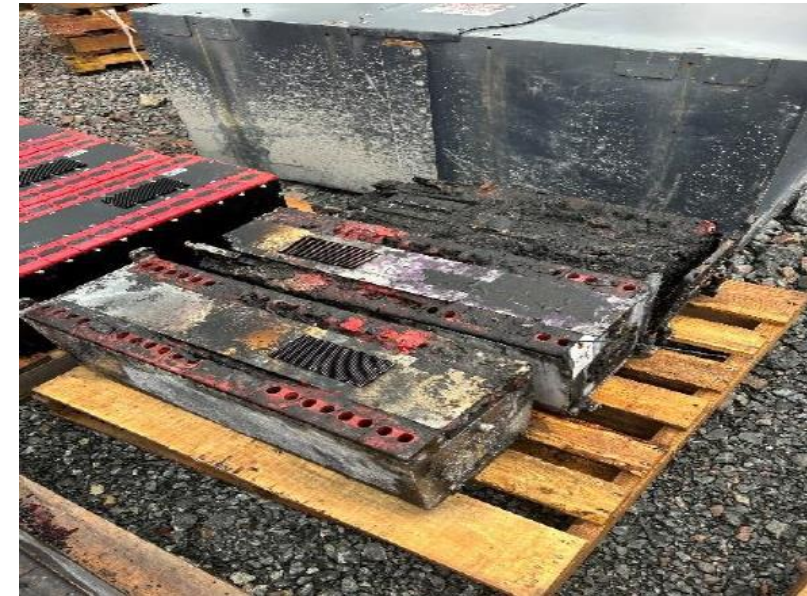
- Batteries stored on the surface exposed to the elements increase the degradation and deterioration of components within the battery pack, increasing the likelihood of shorting.

- Moving decommissioned batteries that have been in prolonged storage and may have degraded in the elements greatly increases the potential for shorting/isolation faults to occur.

- Due to the inability to fully discharge the battery packs because of isolation faults, all modules or cells within may still have an electrical potential within the battery pack, if a short occurs, there is a higher likelihood or potential of fire.

- Prolonged storage in adverse conditions allowed water to enter the battery pack and add to the rate and extent of deterioration of the battery components within.

- Storing decommissioned batteries outside for an extended period due to the lack of storage facilities on site and lack of disposal/recycling ability in the industry.

Recommendation	By When
1.	All batteries stored on the surface will have all modules removed and stored on pallets to minimize fault severity and occurrence and maintained on a regular basis moving forward.	26 Jul 2023 Complete

2.	Develop a formal SOP to deal with batteries deemed unserviceable, to include testing, dissipating any potential charge, safe storage, dismantling (removing modules and cells), and packaging for disposal and recycling.	31 Aug 2023 SOP developed

3.	Live parts on modules are to be covered to prevent moisture from entering modules.	15 Sep 2023 Complete
4.	All retired batteries underground will be sent to the surface to have modules isolated on the surface and stored separately.	26 Jul 2023 Complete

5.	Test all Atlas Copco truck batteries for isolation faults before transportation to the surface.	13 Jul 2023 Complete
6.	Look into finding proper disposal or removal from the site of lithium-ion battery cells stored on the surface to a suitable disposal/recycling facility.	10 Aug 2023 Ongoing

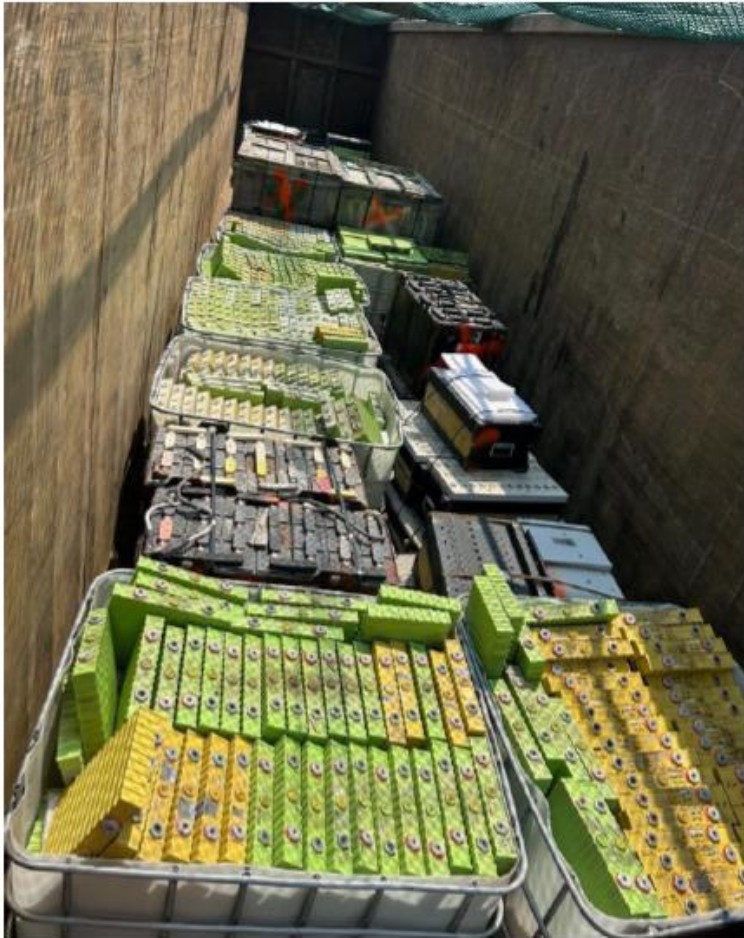
Packaged in trailer prior to fire

On July 10<sup>th</sup> a trailer laden with battery cells from Macassa, left a logistics yard in Amos QC after having been re-packaged and reloaded onto a third party tractor trailer. Shortly after the CMV departed, the driver of the truck was flagged down to advise there was smoke coming from the trailer. The CMV came to a stop at a location off the highway where the Amos municipal fire department responded to extinguish the fire. It was determined, post incident that a number of the isolated cells had come into contact with metal components of either the tote bins they were stacked in or structural components of the trailer, resulting in the battery terminals shorting out, causing a fire which then propagated to adjacent battery cells.

Modules on the pallets are fine but should be shipped at 50% charge capacity or less. The + and –terminals should be removed or insulated to protect against shorting. Modules sent by Macassa were deemed less than 50%.

Cells are to be shipped in a wooded crate single stacked with the + and –terminals upwards with an insulating medium to protect against un-intentional shorts on top of the cells.

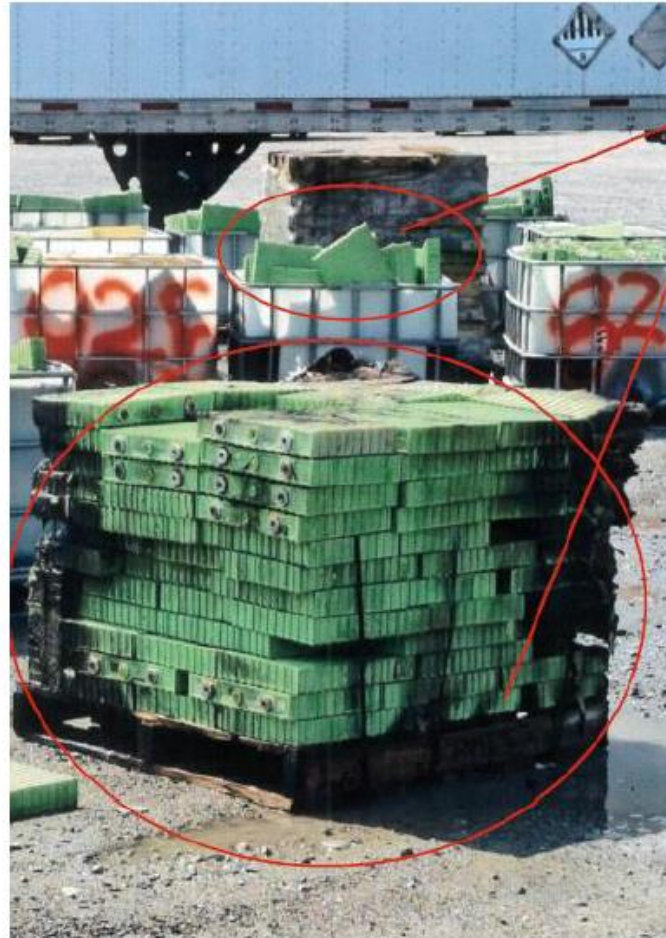
Contents removed from trailer

Cells had been re-packaged off-site.

- Cell configuration has changed in the plastic tote
- Cells were re-palletized and not as they were shipped off-site.

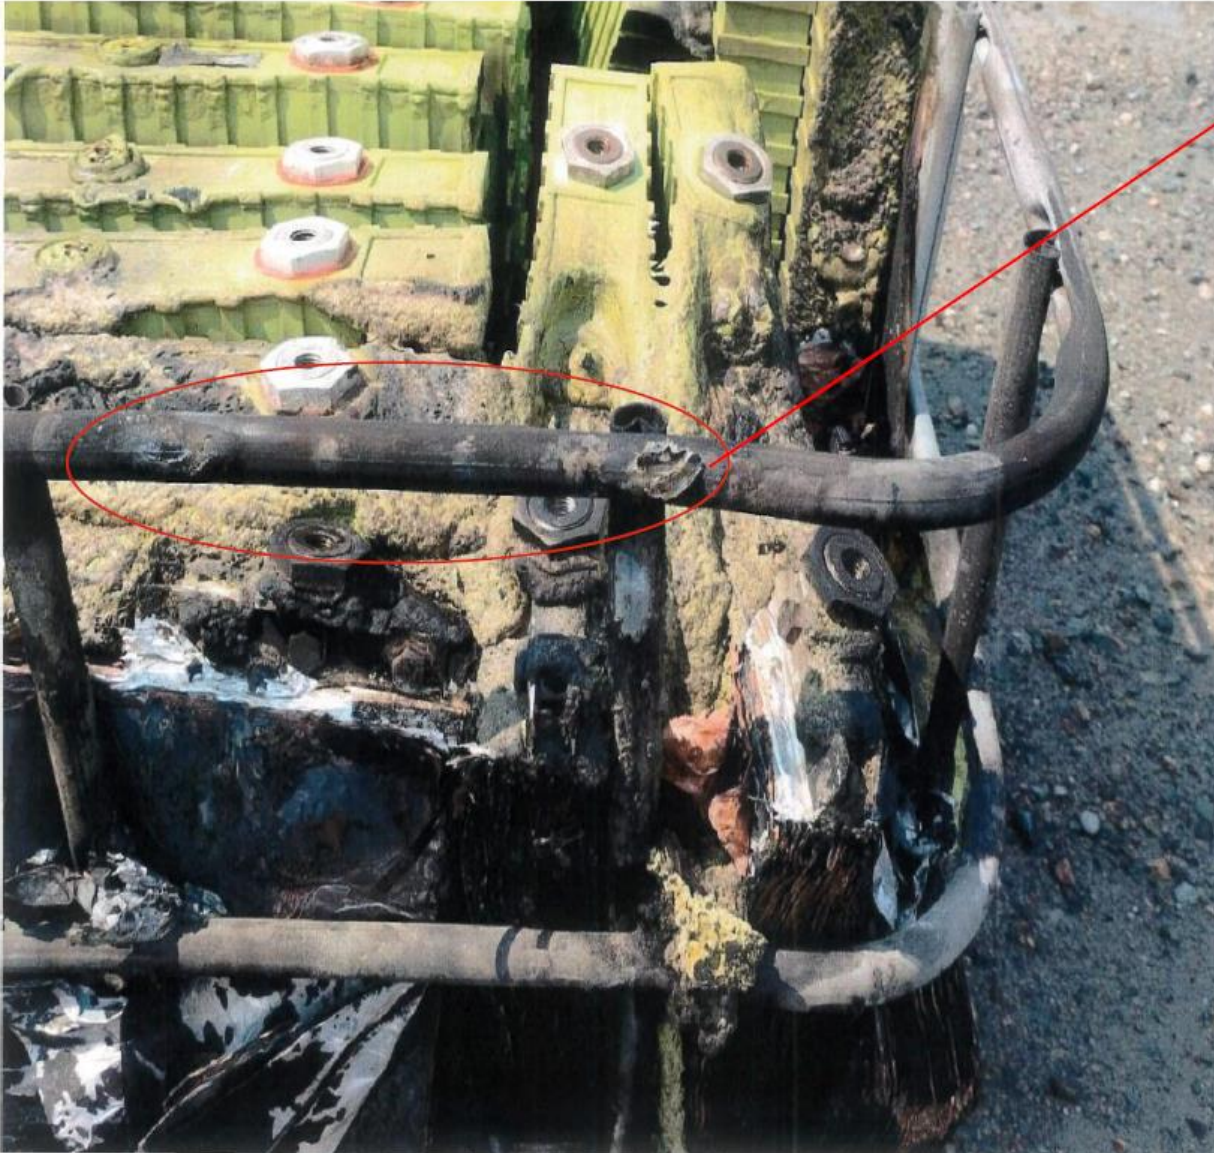
What we see in this picture are weld marks on the outside of the tote in the same general spacing of the + and - terminals from one of the cells that was re-palletted on the wooden skid from the previous picture. I believe a cell had made contact with the aluminum frame and started to arc (weld) itself causing high heat which in turn ignited the plastic of the tote. I believe this served as a catalyst for the fire in the trailer

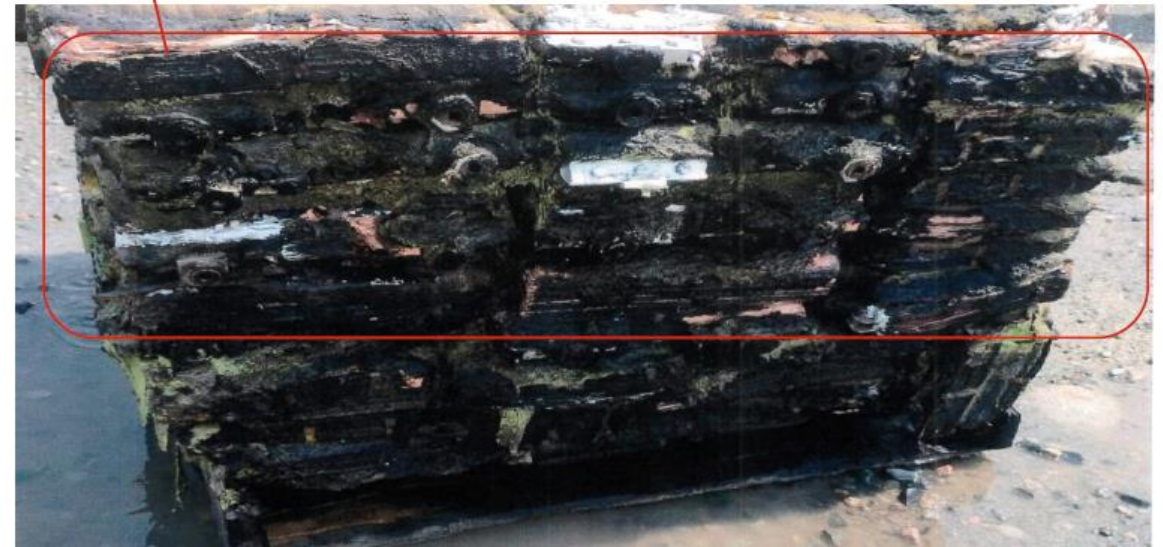
Photo from the re-palletted cells in conjunction with the picture of the weld marks suggests this is the pallet that had made contact with the frame of the tote.

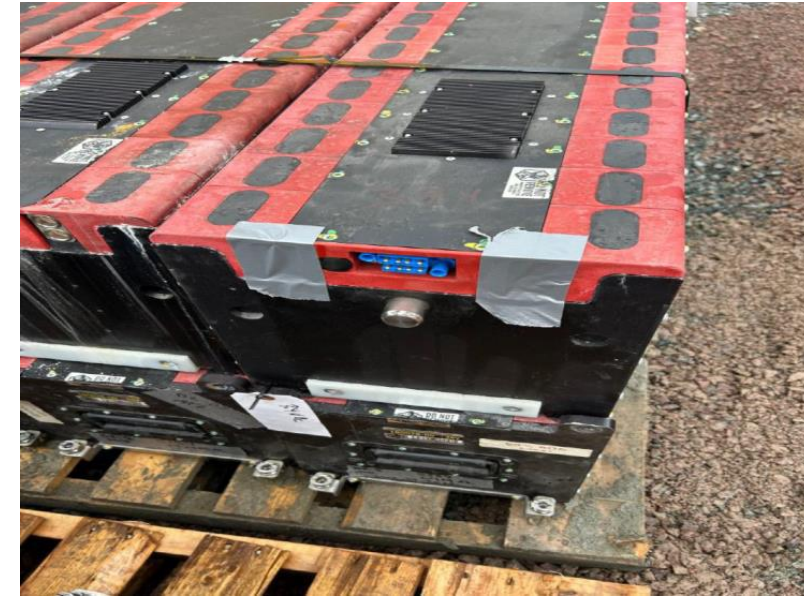
Electrical Crew were assigned to work on surface on July 15 to expedite this process. In total 11 Z40/50 batteries were further isolated during the shift and brought down to the module form seen in the picture.

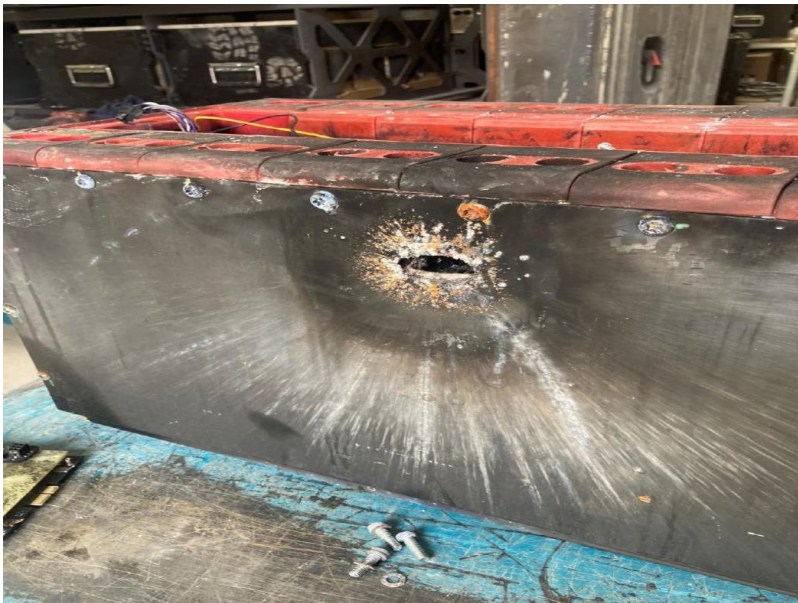
Upon tear down on BZ55 on July 15<sup>th</sup> it was noted that a thermal event had occurred at an unknown time and date inside this battery. It was observed that 3 modules had roughly a loonie sized hole blown through the side of the modules in basically the same area as the CM board location.

BZ0055 history: New pack in April of 2021 and put into service. Was sent to Sandvik for refurbishment approximately 6 months later. Flex circuit upgrades and module replacement. Battery pack was pulled out of service due to poor AH rating in August of 2022 and was sent to surface

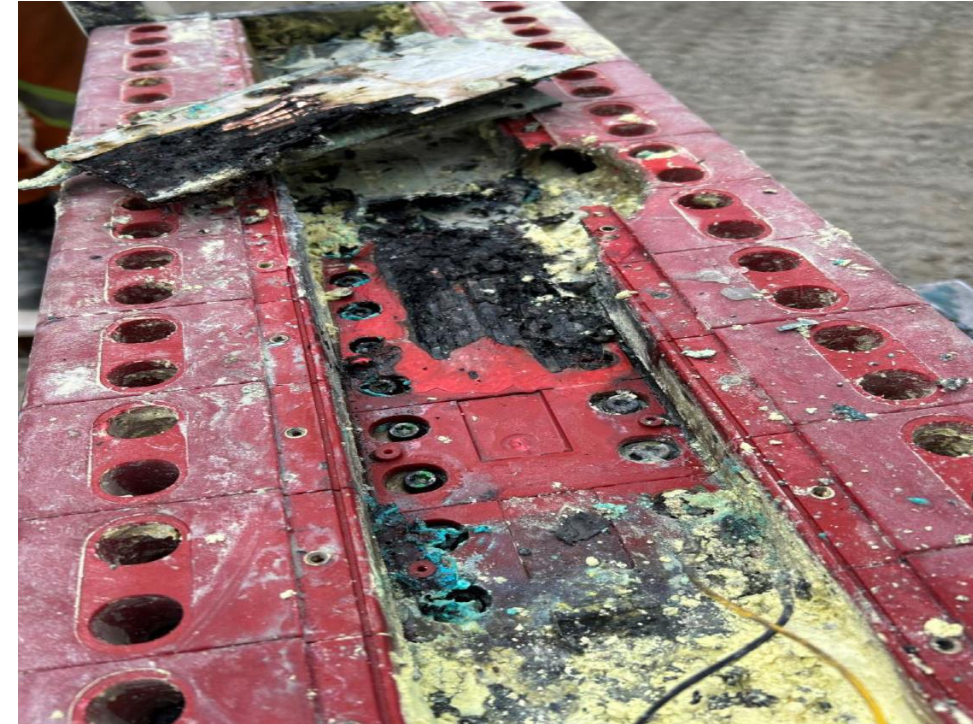
Upon arrival to investigate, heavy smoke was noticed coming from the module. The module top was observed to be heavily melted around the CM board area of the module. The surface loader operator was instructed to bring over a large tote of water so the module could be submerged to stop the thermal process. While waiting for the tote, a small flame was noticed in the CM board location of the module.

Module was then fully submerged in the tote. At this time, a second module was noticed to have started emitting smoke. No open flame was observed, but damage due to heat was also noticed in the same location as the first module. Around the CM board location. This module was also submerged to stop the thermal process.

An investigation was completed the afternoon of the 17<sup>th</sup> on the two modules and the cause was found to be tracking under the CM board due to moisture. This led to the module itself shorting out.

Actions taken were to remove the module tops that house the CM board and Flex tape circuit which also would remove the buss bars from the individual cells further isolating them down to individual cell voltages of ~3.6 volts. The modules with the “module tops” removed have been wrapped in plastic to keep water from entering.

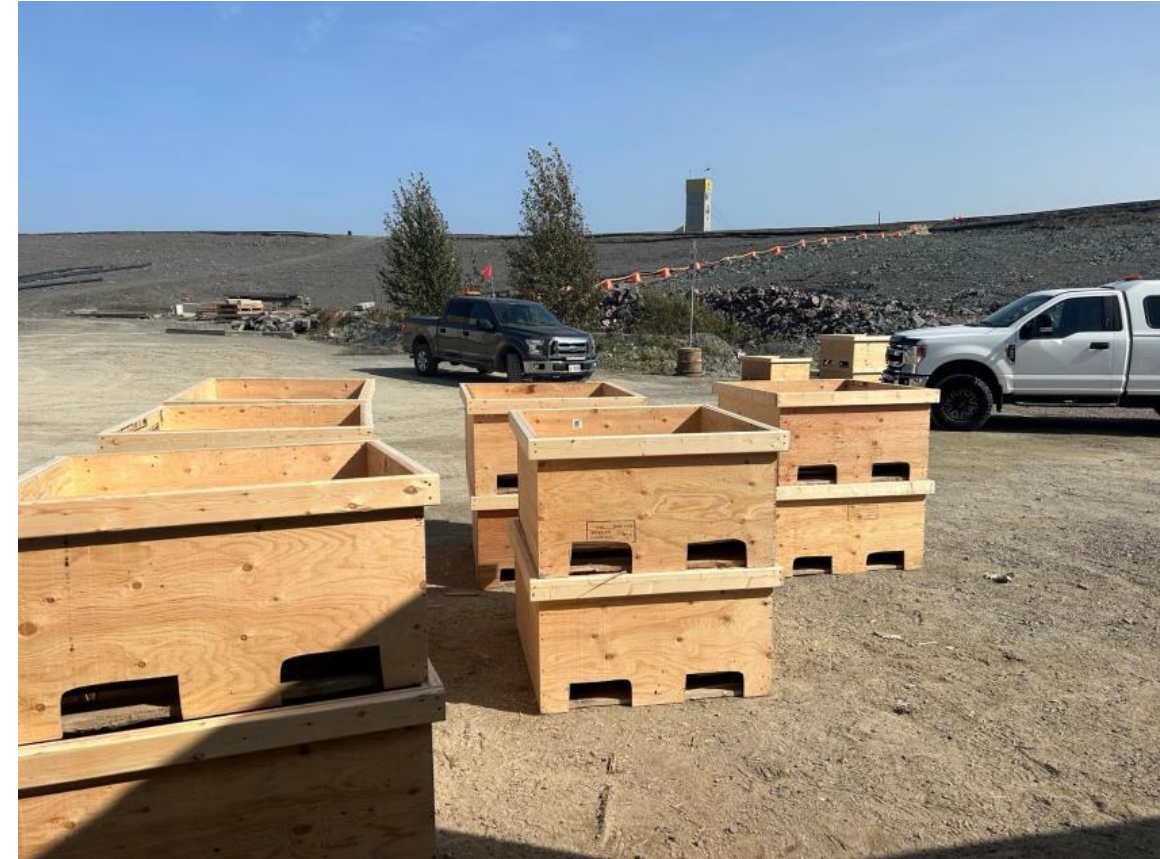
Z40 / Z50 Battery, located on surface in the One-Haul lay-down yard, began to off-gas. The battery ignited causing a thermal event. The battery compartment pressurised. An internal arc created an ignition which blew the side compartment doors off. Surface crew began to apply water to the battery in order to cool the unit down. Additional arcing and short circuiting caused the venting gasses to combust resulting in a fire. The KLFD was called to the scene to apply additional water and foam. The fire was fully extinguished, and the battery modules were isolated to prevent a further thermal event. The battery was transported to the Thickener building under security camera 24hr surveillance as fire-watch.

- We believe it was caused by water ingress into the battery pack and subsequently into a module
- The battery was left outside, uncovered and allowed to get wet
- The short circuiting caused the cells to overheat and then vent
- The arcing ignited the vented gas and initiated combustion

- There is a susceptibility for water ingress into the pack (when the battery pack is removed from the vehicle cage assembly). If water gets into the individual battery module cover it could lead to isolation breakdown and subsequent short circuiting.

- It was discovered on the day of the event that the top cover gasket was on the wrong side of the bolt holes; this could have allowed water to enter the cover and drip on the top of the battery module.

- The arcing on the top of the batteries is consistent with water pooling on the module tops as was the case with the isolated modules that previously burnt on surface.

- Loose battery packs must be protected from getting wet. They need to be kept indoors or covered.
- The battery sat on surface in the elements longer than we had intended.

- Batteries that are sent to surface, have their bus-bars removed to prevent any potential short-circuiting propagation from one module to another. Cells are also isolated with each module. The modules are then packaged in plywood boxes with weather resistant tops to reduce the potential of water from getting into/onto the isolated cells/modules.
- Standard Operating Procedure developed for battery management.
  - MAC-R112: Battery Isolation Fault Handling
  - MAC-U255: Assessing Batteries

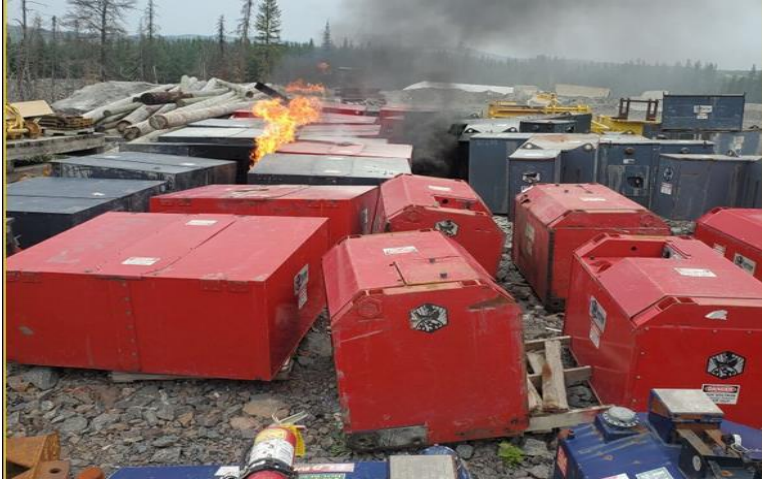
BZ007 Battery pack in surface battery storage area in close proximity to other decommissioned batteries.

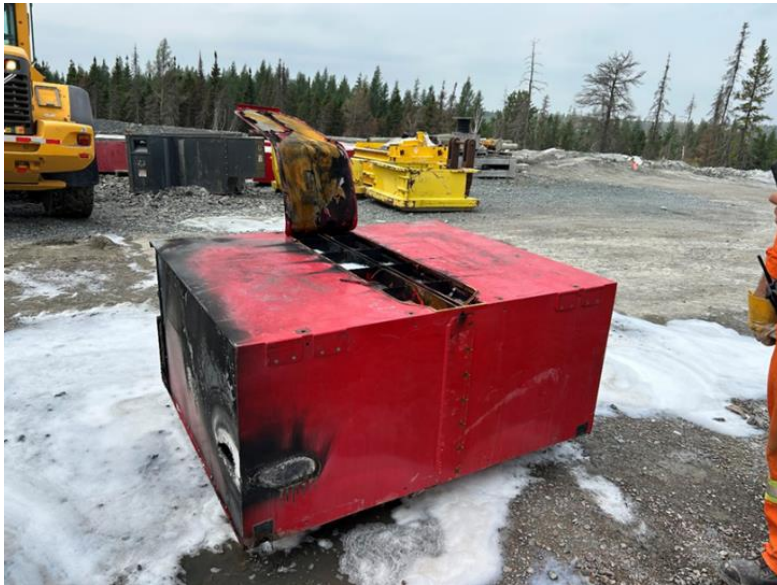
Battery pack after being extinguished and moved to a safe location. The top panel was opened by the fire department to aid in firefighting efforts (water and AFFF).

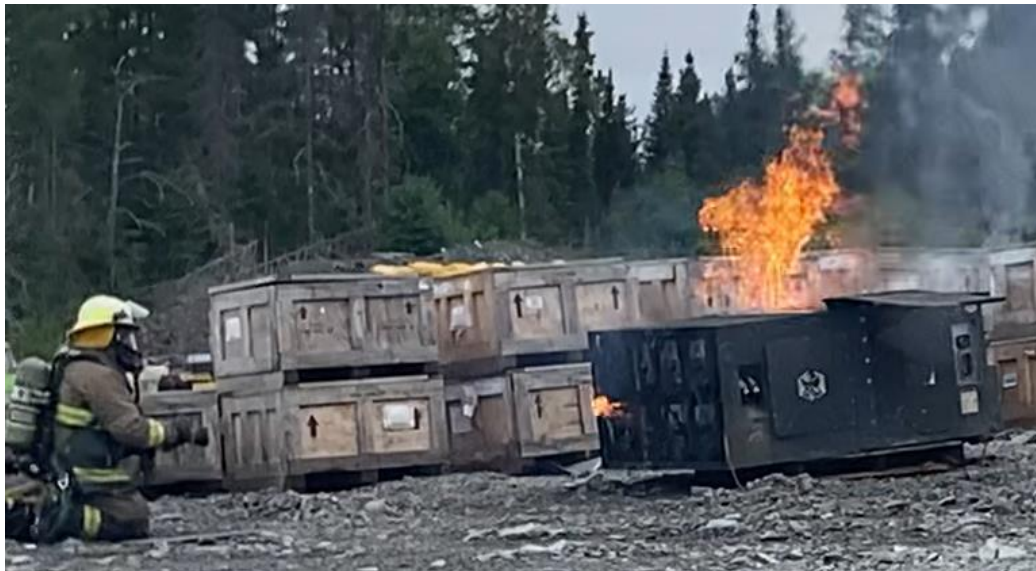
Initial deployment of water/foam

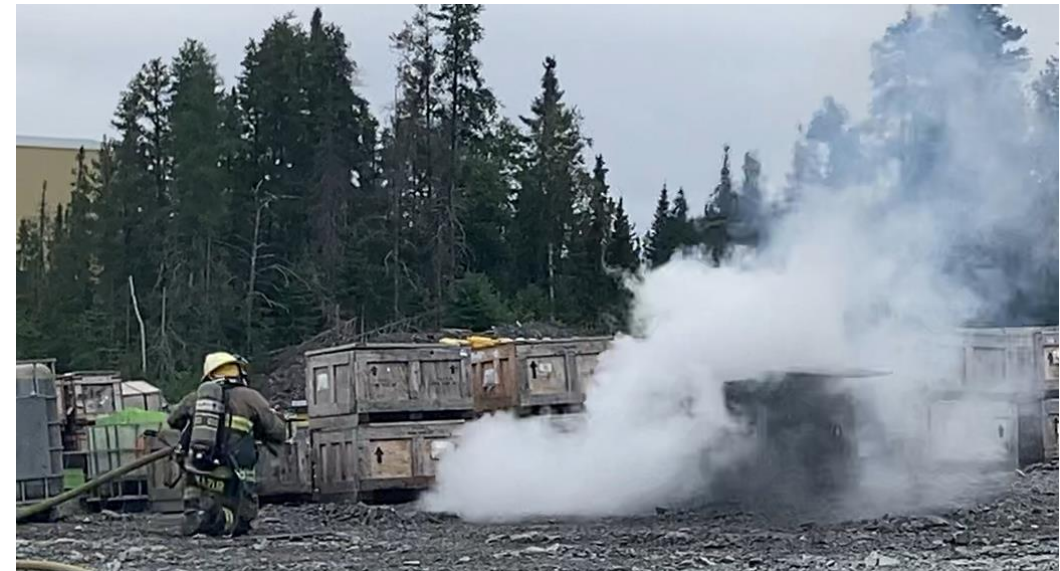
6-seconds after initial application of water/foam
