Incident Summary

Onaping Depth BEV Fire

2020-07-06

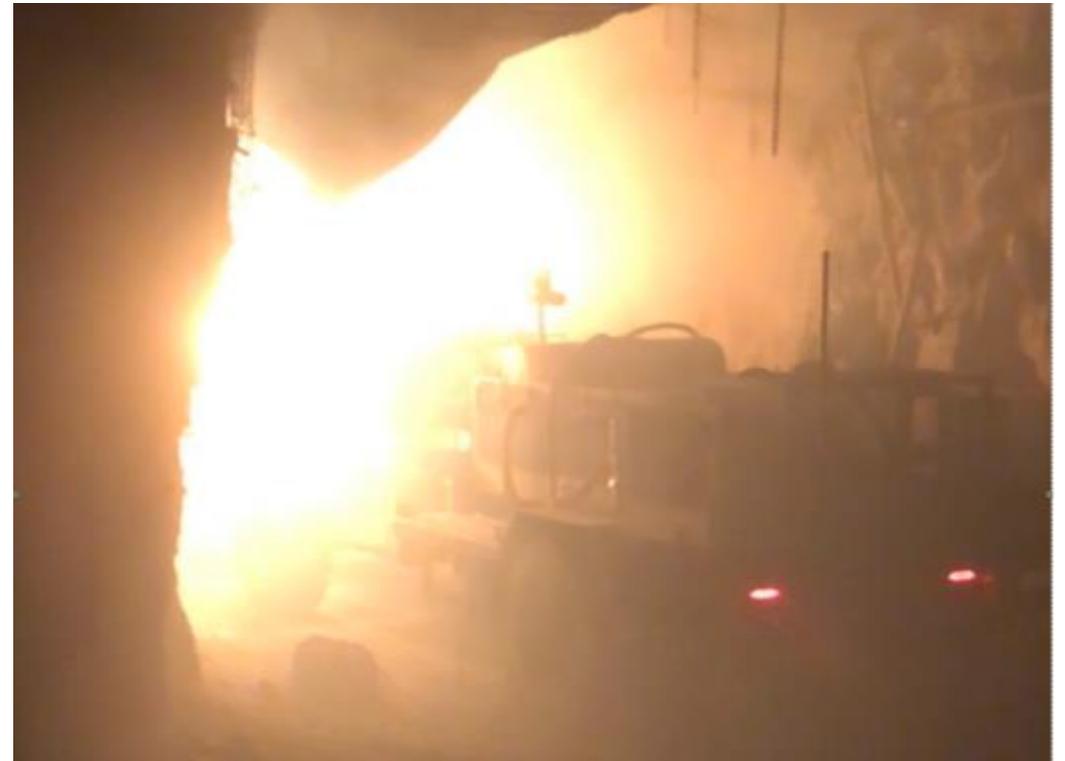
Figure 1 – BEV Fire

- On the evening of July 6th, two technicians were troubleshooting a battery electric vehicle (BEV) located on the 47- 4 level at Craig Mine in Onaping, Ontario.
- At approximately 10:40pm, while working on the unit a sudden high intensity electrical arcing event and fire took place.
- Technicians were trapped behind the burning truck, but for a period of time were able to communicate with first responders to initiate an emergency response.
- They located a functioning compressed air line and remained at the air header until the Mine Rescue team extinguished the fire.
- The technicians were then safely extracted to surface.

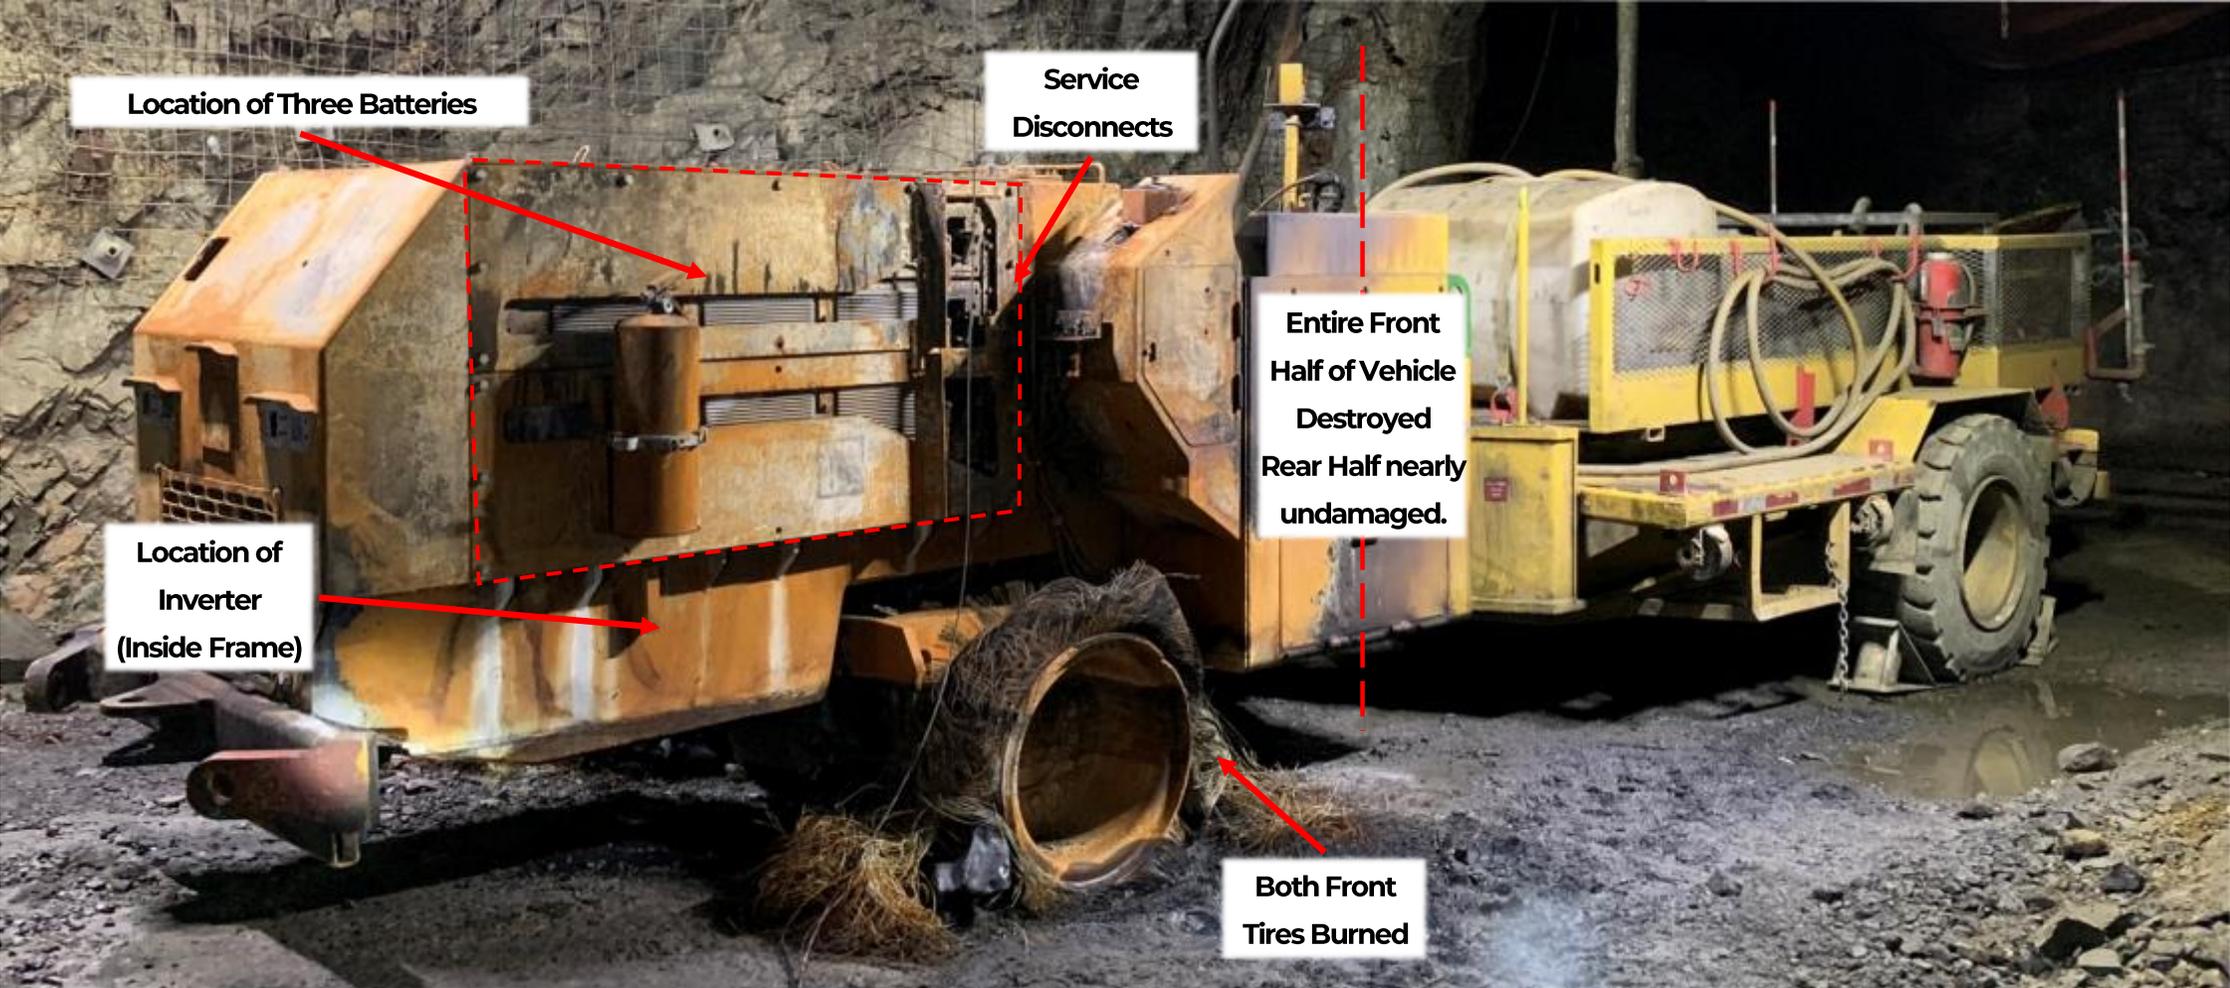
Figure 2 – Post-Incident Photo of BEV

- Prior to the incident, battery fuses were mistakenly removed and replaced with shunts. The vehicle was operated with *no overcurrent protection* in place.
- The BEV's traction inverter failed resulting in a short circuit.
- The uninterrupted short circuit produced a tremendous amount of heat for a prolonged period. This subsequently ignited the battery and front tires, destroying the front half of the vehicle.

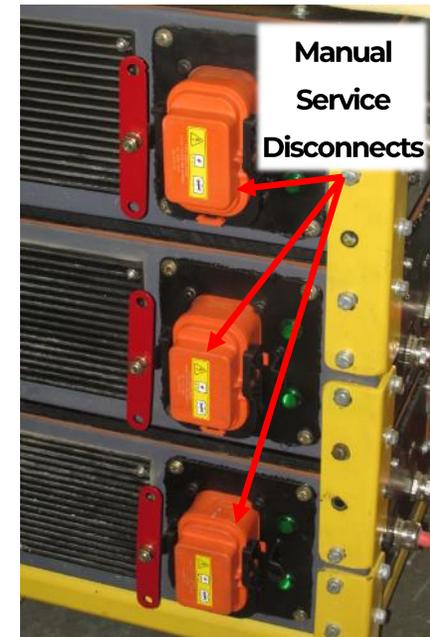
Figure 4 – Manual Service Disconnects

- Vehicle was delivered to OEM's shop in Sudbury in mid-2017.
- Energy storage system consisted of three identical battery packs. Each pack was equipped with an internal fuse, as depicted in Figure 3.
- During an early vehicle inspection, Glencore noted the absence of an external means of achieving a zero-energy state during maintenance and requested that this feature be added.
- To address this, one manual service disconnect per battery pack with unfused modules (i.e. shunts) was installed (see Figures 4 and 5).
- Vehicle was put into service at Craig Mine in Sept 2017.

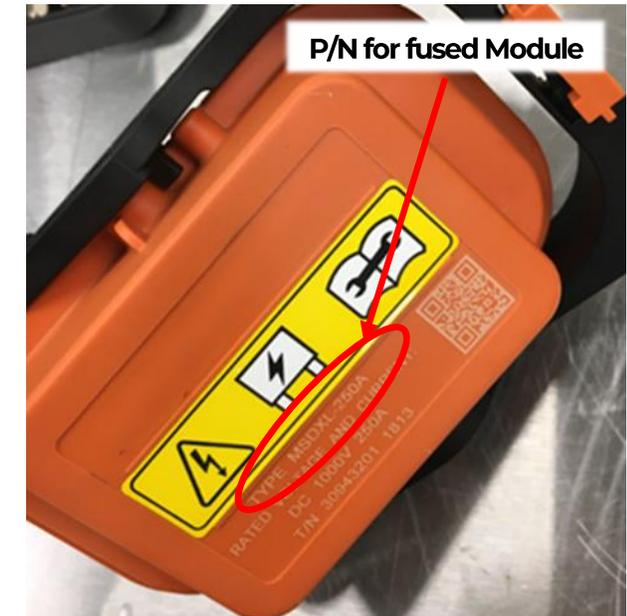
Figure 6 – Fused Module

- Improper towing resulted in traction inverter damage and blown fuses. The inverter and original fuses needed to be replaced.
- Accessing the fuses required unmounting and disassembling each battery pack. It was noted that a module with an integrated fuse was available for the manual service disconnect which would make replacing fuses easier in the future.
- The following modifications to the design were made in conjunction with changes to the towing procedure:
 - Three 250A fused modules were used to replace the unfused modules (see Figure 5)
 - The original, internal fuses were eliminated.
- The removed unfused modules were kept in inventory.

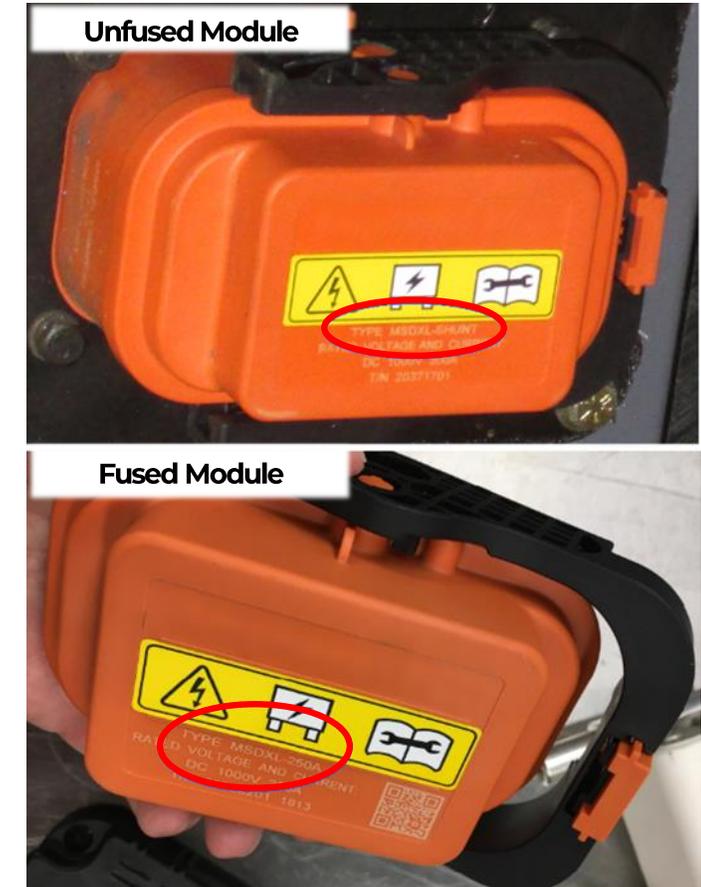
Figure 7 – Comparison of Modules

- Another improper towing incident occurred damaging the traction inverter
 - Once again the inverter and fuses needed to be replaced
 - A further revision to the towing method and procedure was also made.
- Instead of the required 250A fused modules, the unfused modules that were previously removed were erroneously re-installed.
 - The fused and unfused modules are identical in appearance apart from the model number printed in small text (see figure 7).
- The vehicle was returned to service and operated with ***no overcurrent protection in place*** for the main battery and traction inverter.

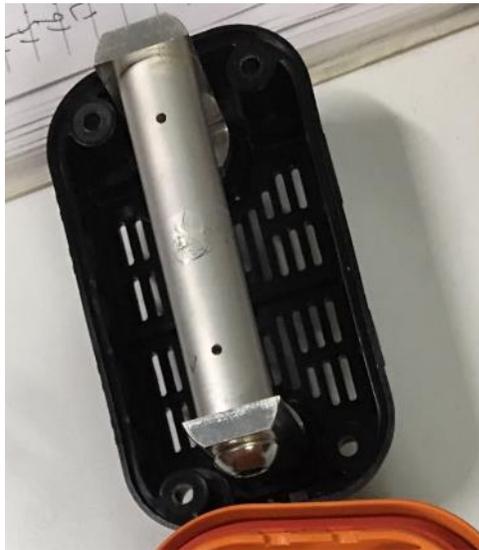
Figure 8 – Unfused Module (Internal)

- The inverter failed while OEM technicians were troubleshooting. With no overcurrent protection in place, a severe and uncontrolled electrical fault occurred.
- The investigation found unfused modules installed instead of the correct fused modules (see figure 8 and 9 comparing as found to new).

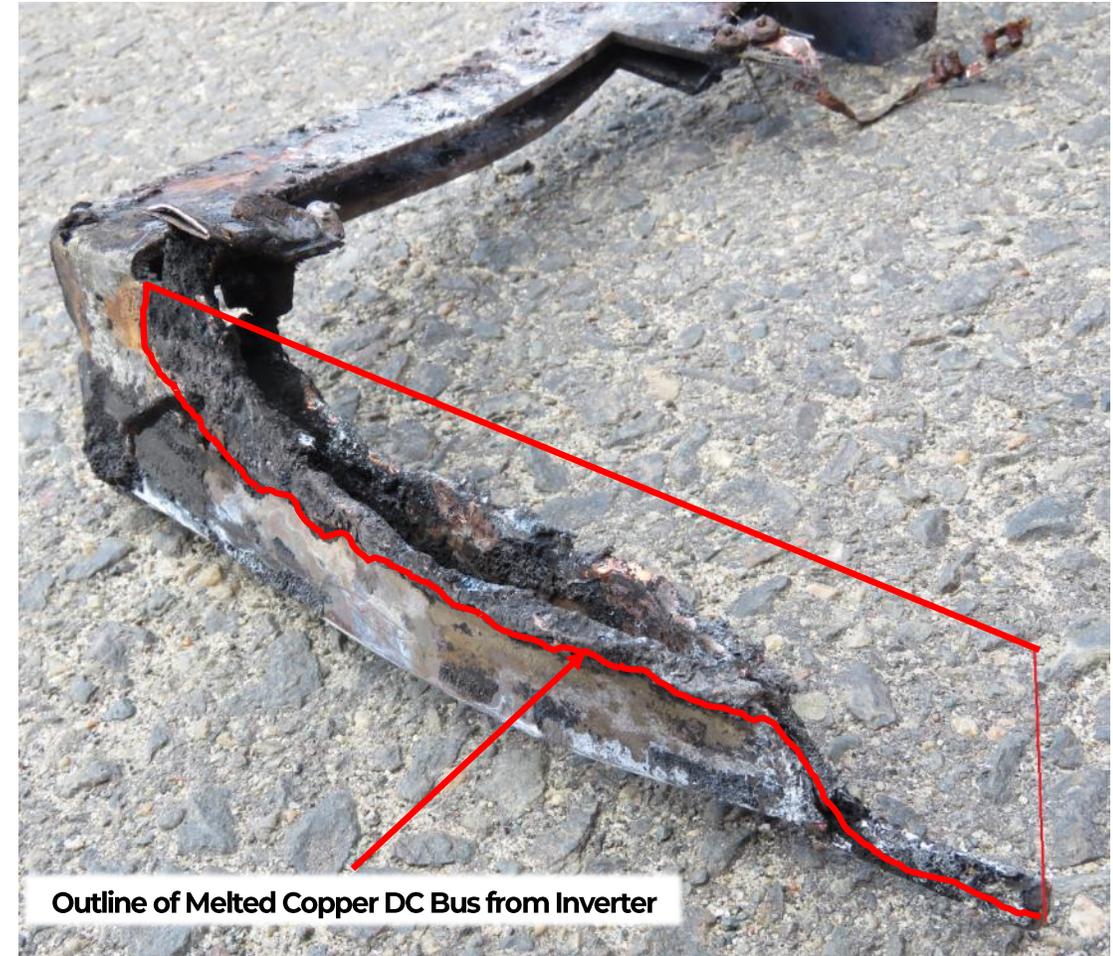
Figure 10 – Internal DC Bus Bar extracted from Failed Traction Inverter

- The traction inverter was totally destroyed as a result of the failure.
- The failed inverter was further disassembled which revealed a significant portion of the traction inverter copper bus melted away (see figure 10).
- This is clear evidence of a prolonged and uncontrolled electrical fault that originated in the traction inverter which generated a tremendous amount of heat.

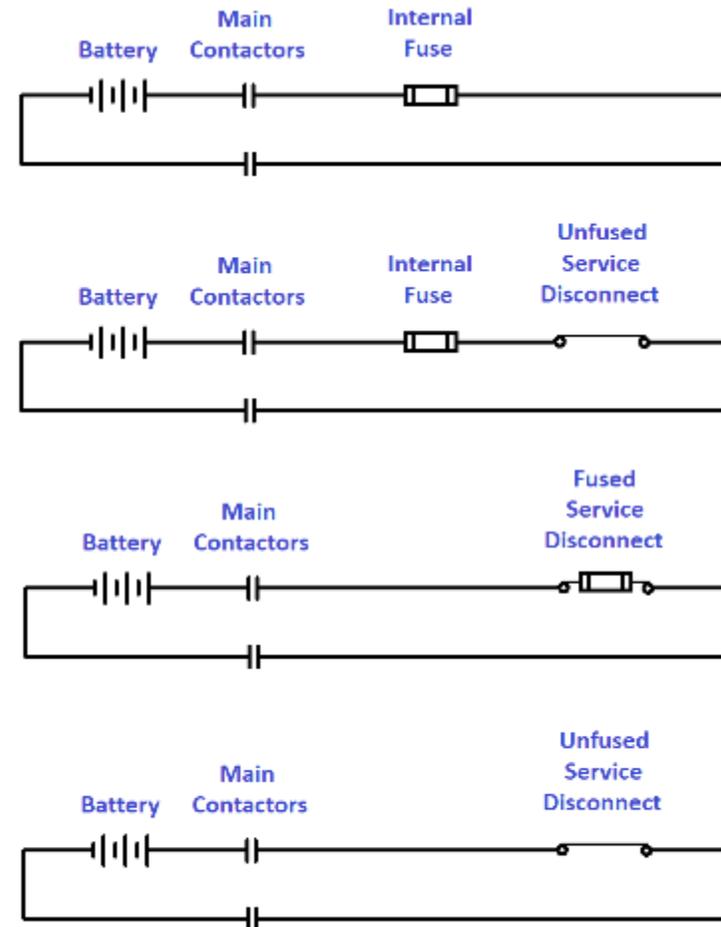
Figure 11 – Simplified Schematics depicting modifications to fuse arrangement.

- Figure 11 is a set of simplified battery pack schematics depicting the modifications that took place over the life of the battery electric vehicle leading up to the fire

1) Original design was fused, but did not include an external disconnecting means to achieve zero energy.

2) Unfused service disconnect module was added to satisfy the need to achieve zero energy during servicing.

3) Unfused service disconnect was replaced with a fused version. This eliminated the need for an internal fuse.

4) Fused service disconnect was accidentally replaced with an unfused version. No overcurrent protection is present.

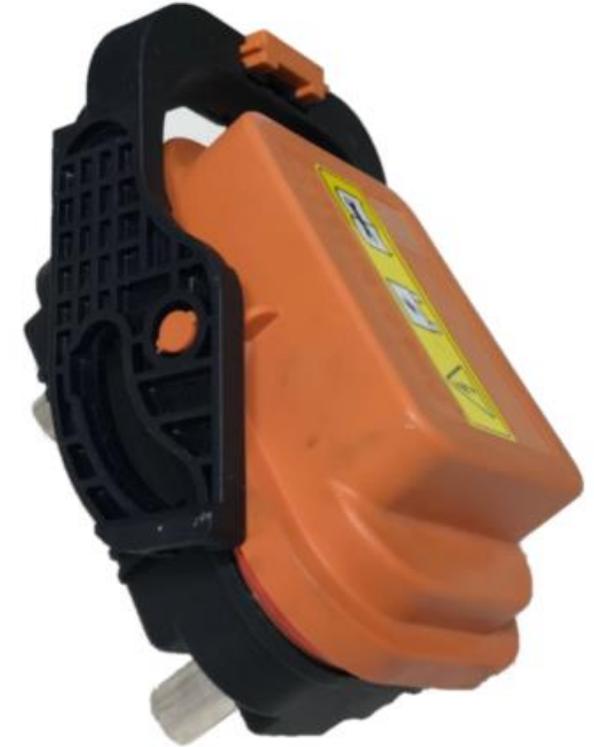
Figure 12 – Service Isolation Device

- Combination disconnect/fuse modules, like the one depicted in Figure 12, can be convenient. But perhaps they are **too** convenient.
 - Anyone can remove/change the module.
 - Easy to change fuse ratings, or as in this incident, eliminate the fuse altogether.
 - Not clearly/boldly marked as to what it is (rating, etc.)
 - Dual purpose – fuse *and* isolation means. This may not be a good thing.
 - If the main battery fuse does blow, should it be really easy to replace?

- Consider specifying that Main fuses/overcurrent protection require a tool to remove or replace. This may help ensure that only authorized persons perform this task.
 - Battery fuses in particular should *never* blow unless a severe fault has occurred. It should not be a “routine” task to replace these – qualified person should be involved.
 - Still need to make sure it is safe for the person to remove/replace the fuses.
- Should ensure that labels are present, indicating make/model/rating of each overcurrent device. This way, it is clear to maintenance personnel what *should* be installed.
- Also need to ensure that the overcurrent protection devices themselves are well marked and easy to identify.
 - A fuse should *look* like a fuse. A circuit breaker should *look* like a circuit breaker. And a copper shunt should *look* like a copper shunt.
