Ontario Mine Rescue

BEV Emergency Response Incident
Review and Best Practices

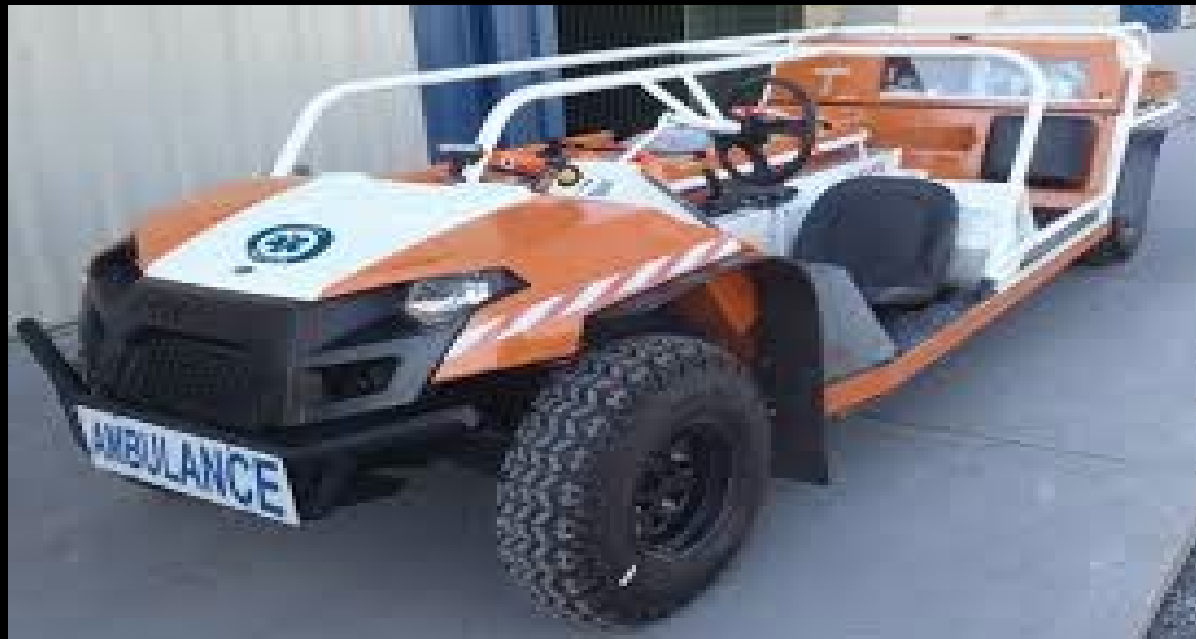
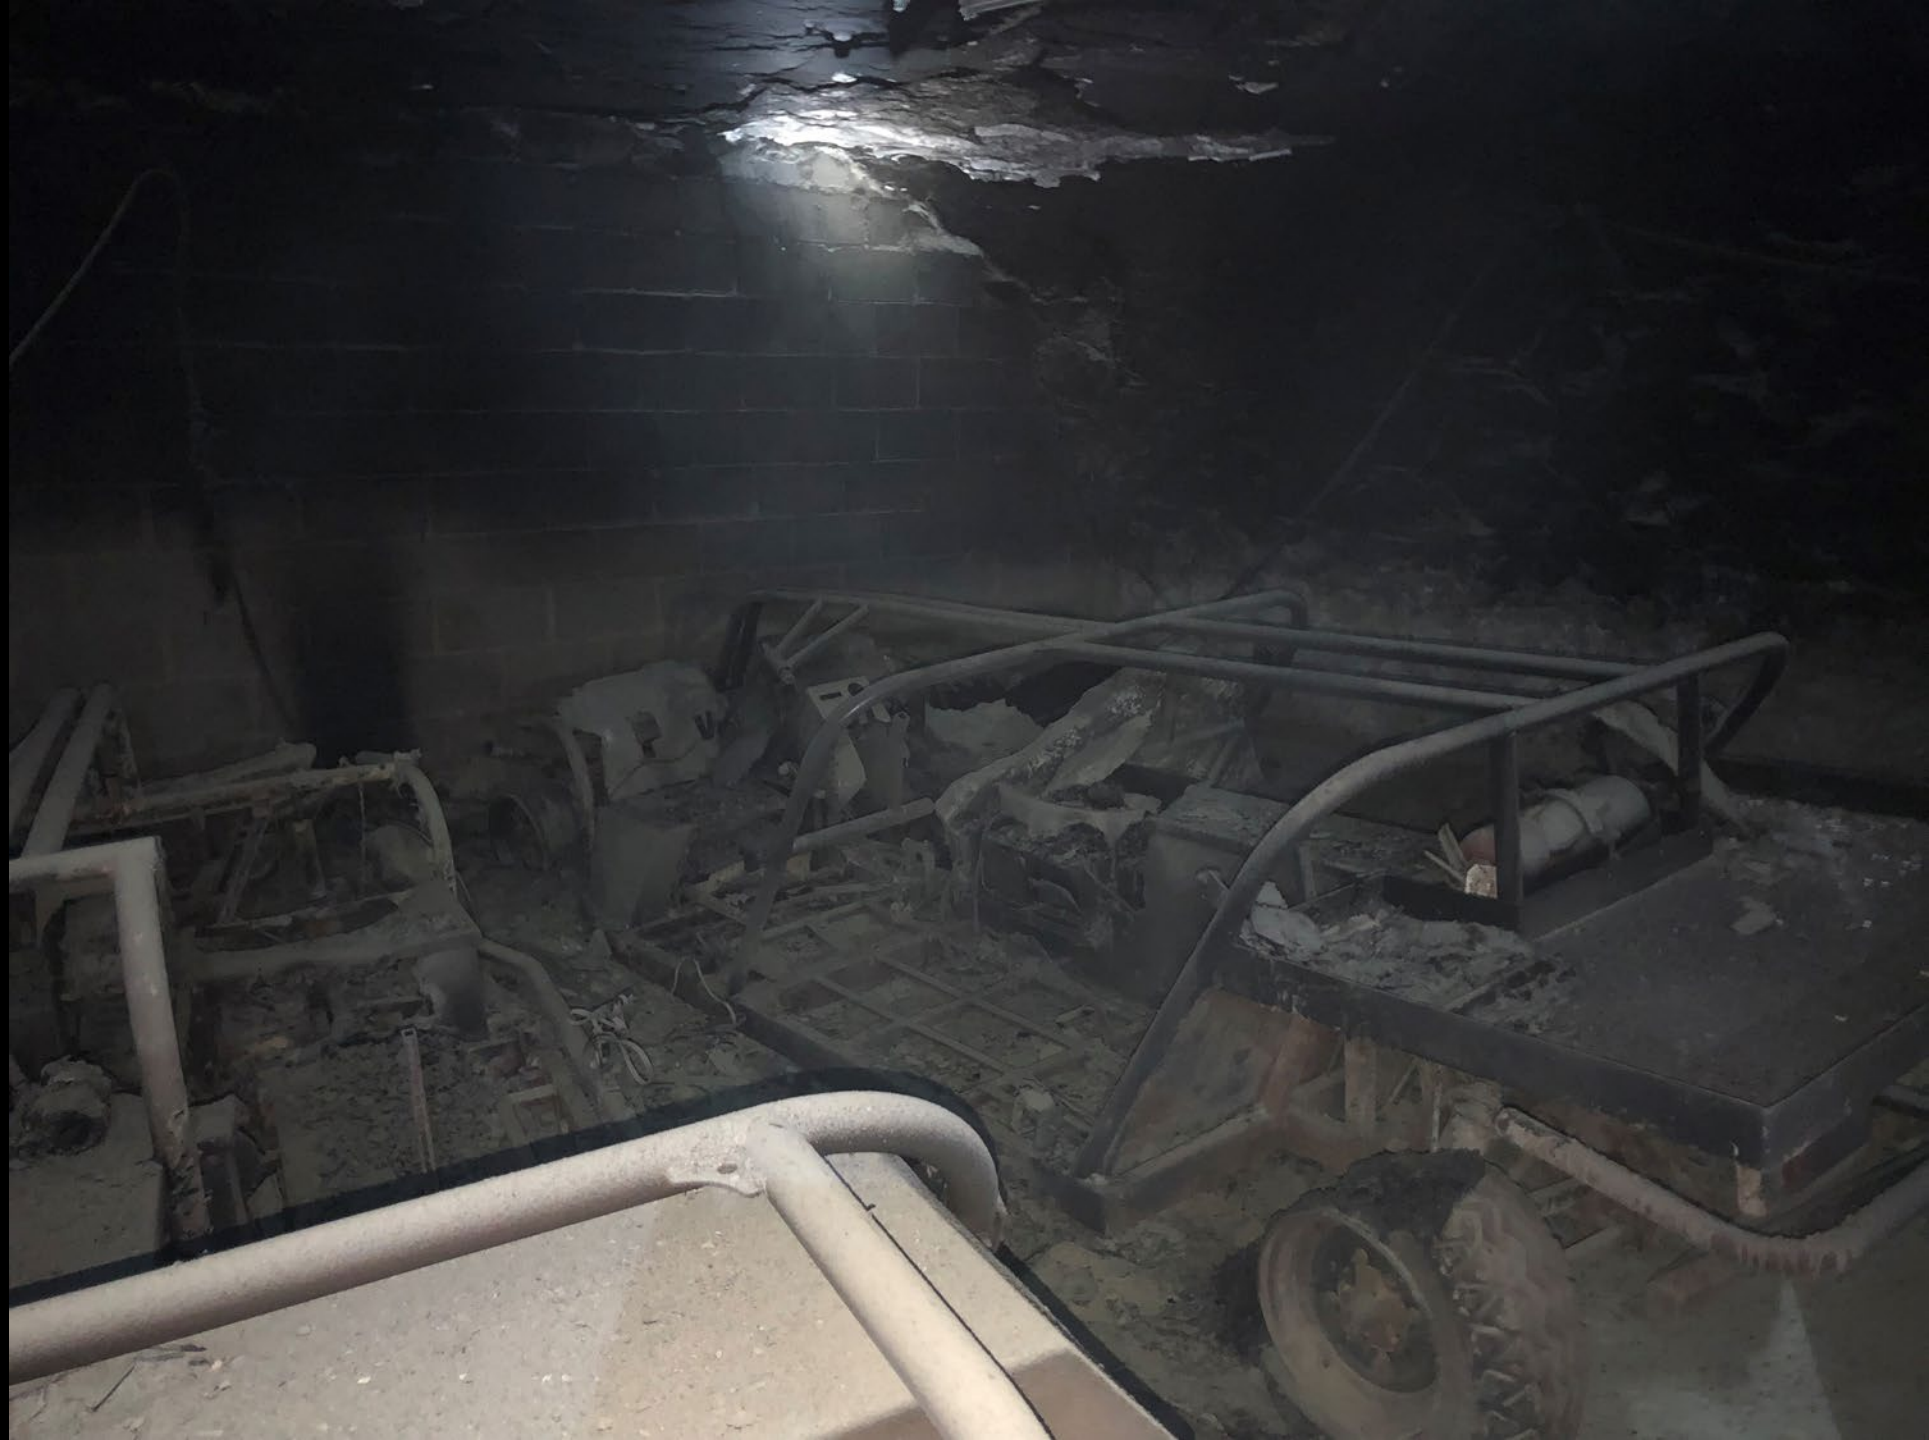
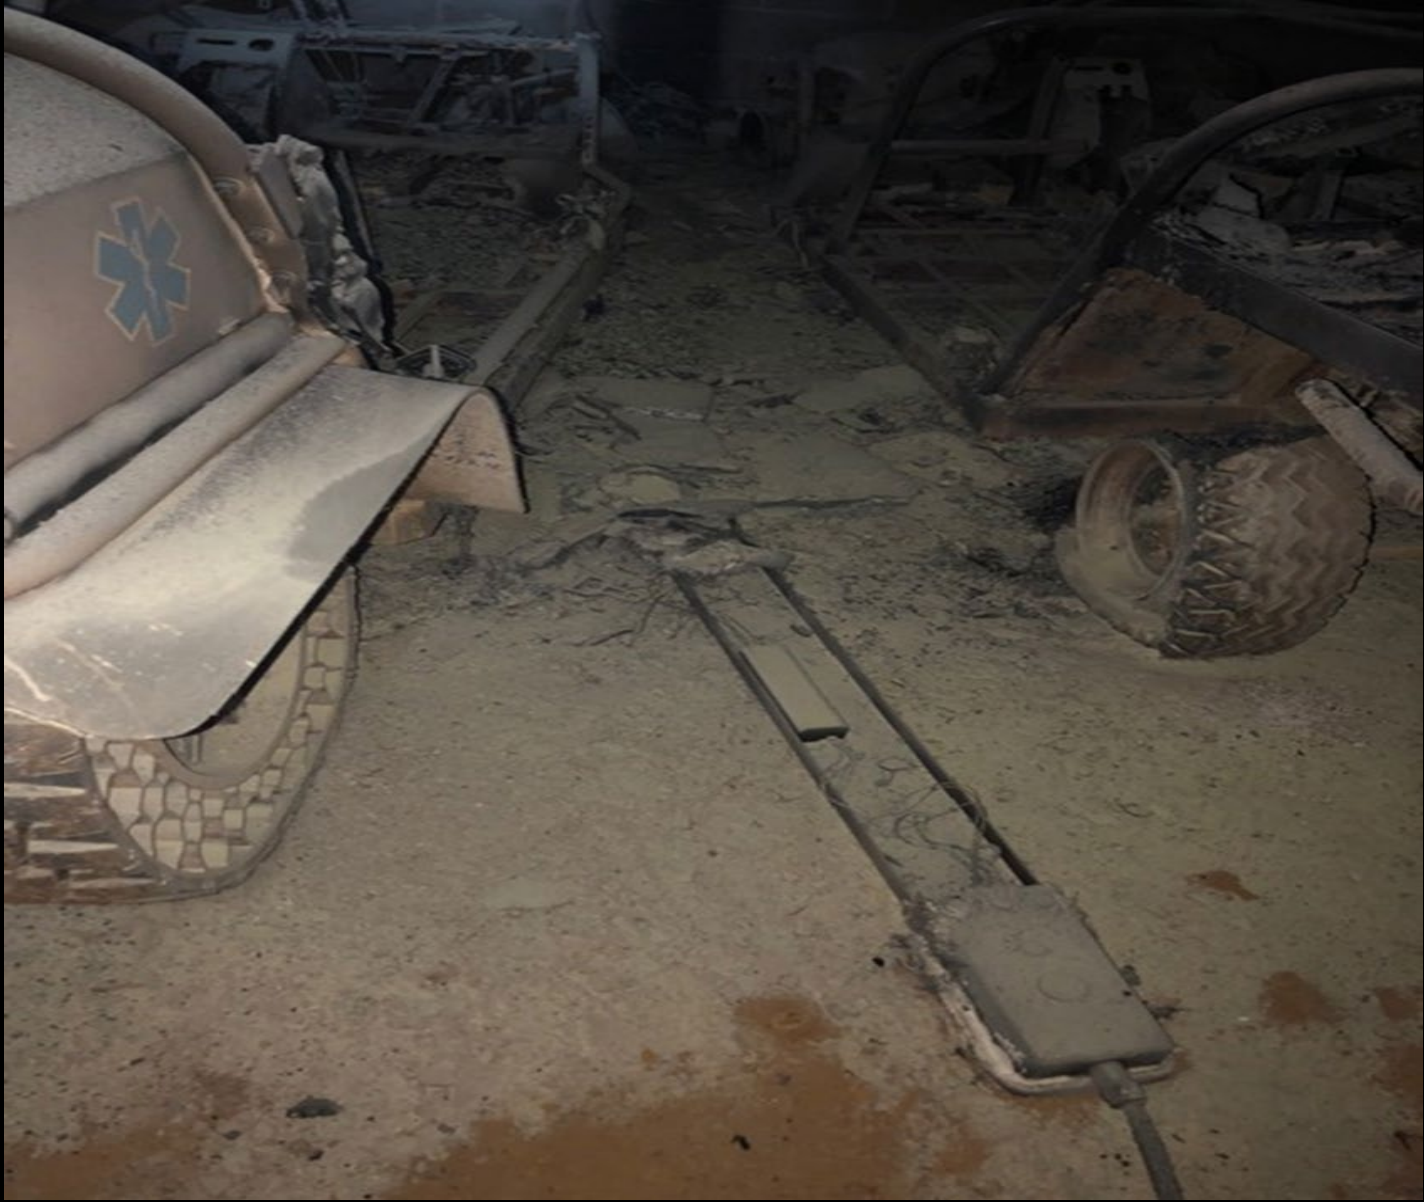
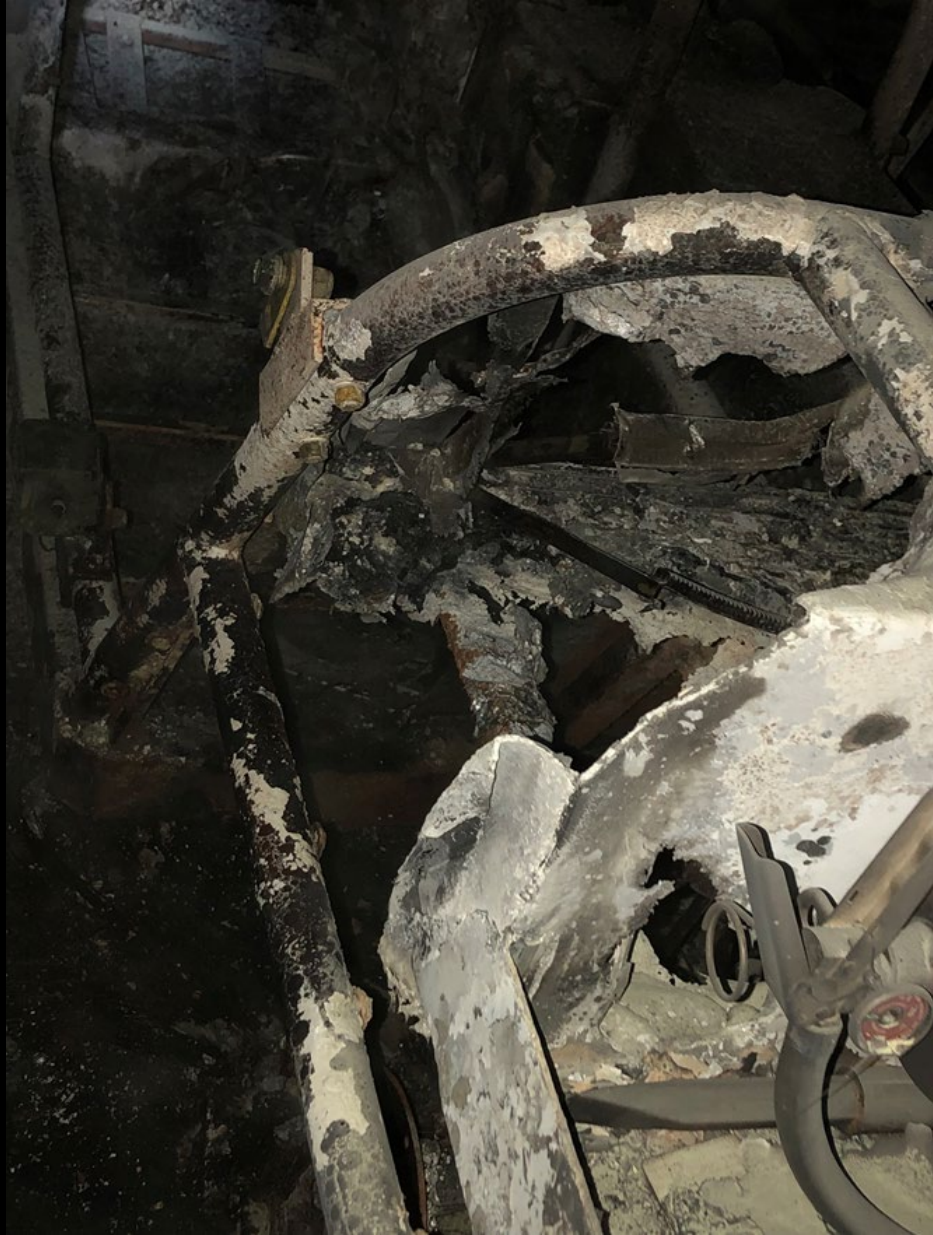
Incident #1 (Southern District)

- Sept 19, 2019 at approximately 17:30 hrs
- An underground worker had noticed black smoke and an orange glow coming from a charging/parking station.
- The worker noted that at least one vehicle was on fire and then proceeded to seek refuge.
- At 17:32 hrs emergency procedures were implemented.
- Black smoke visible at mine shaft entrance
- Smoke exiting RAR forced evacuation of surrounding buildings

- Faulty Charging cable/fixture back fed to first vehicle battery and propagated from there to two more vehicles with extreme heat. Total of 3 vehicles were consumed in the fire along with all lights and conductors in the charging area.

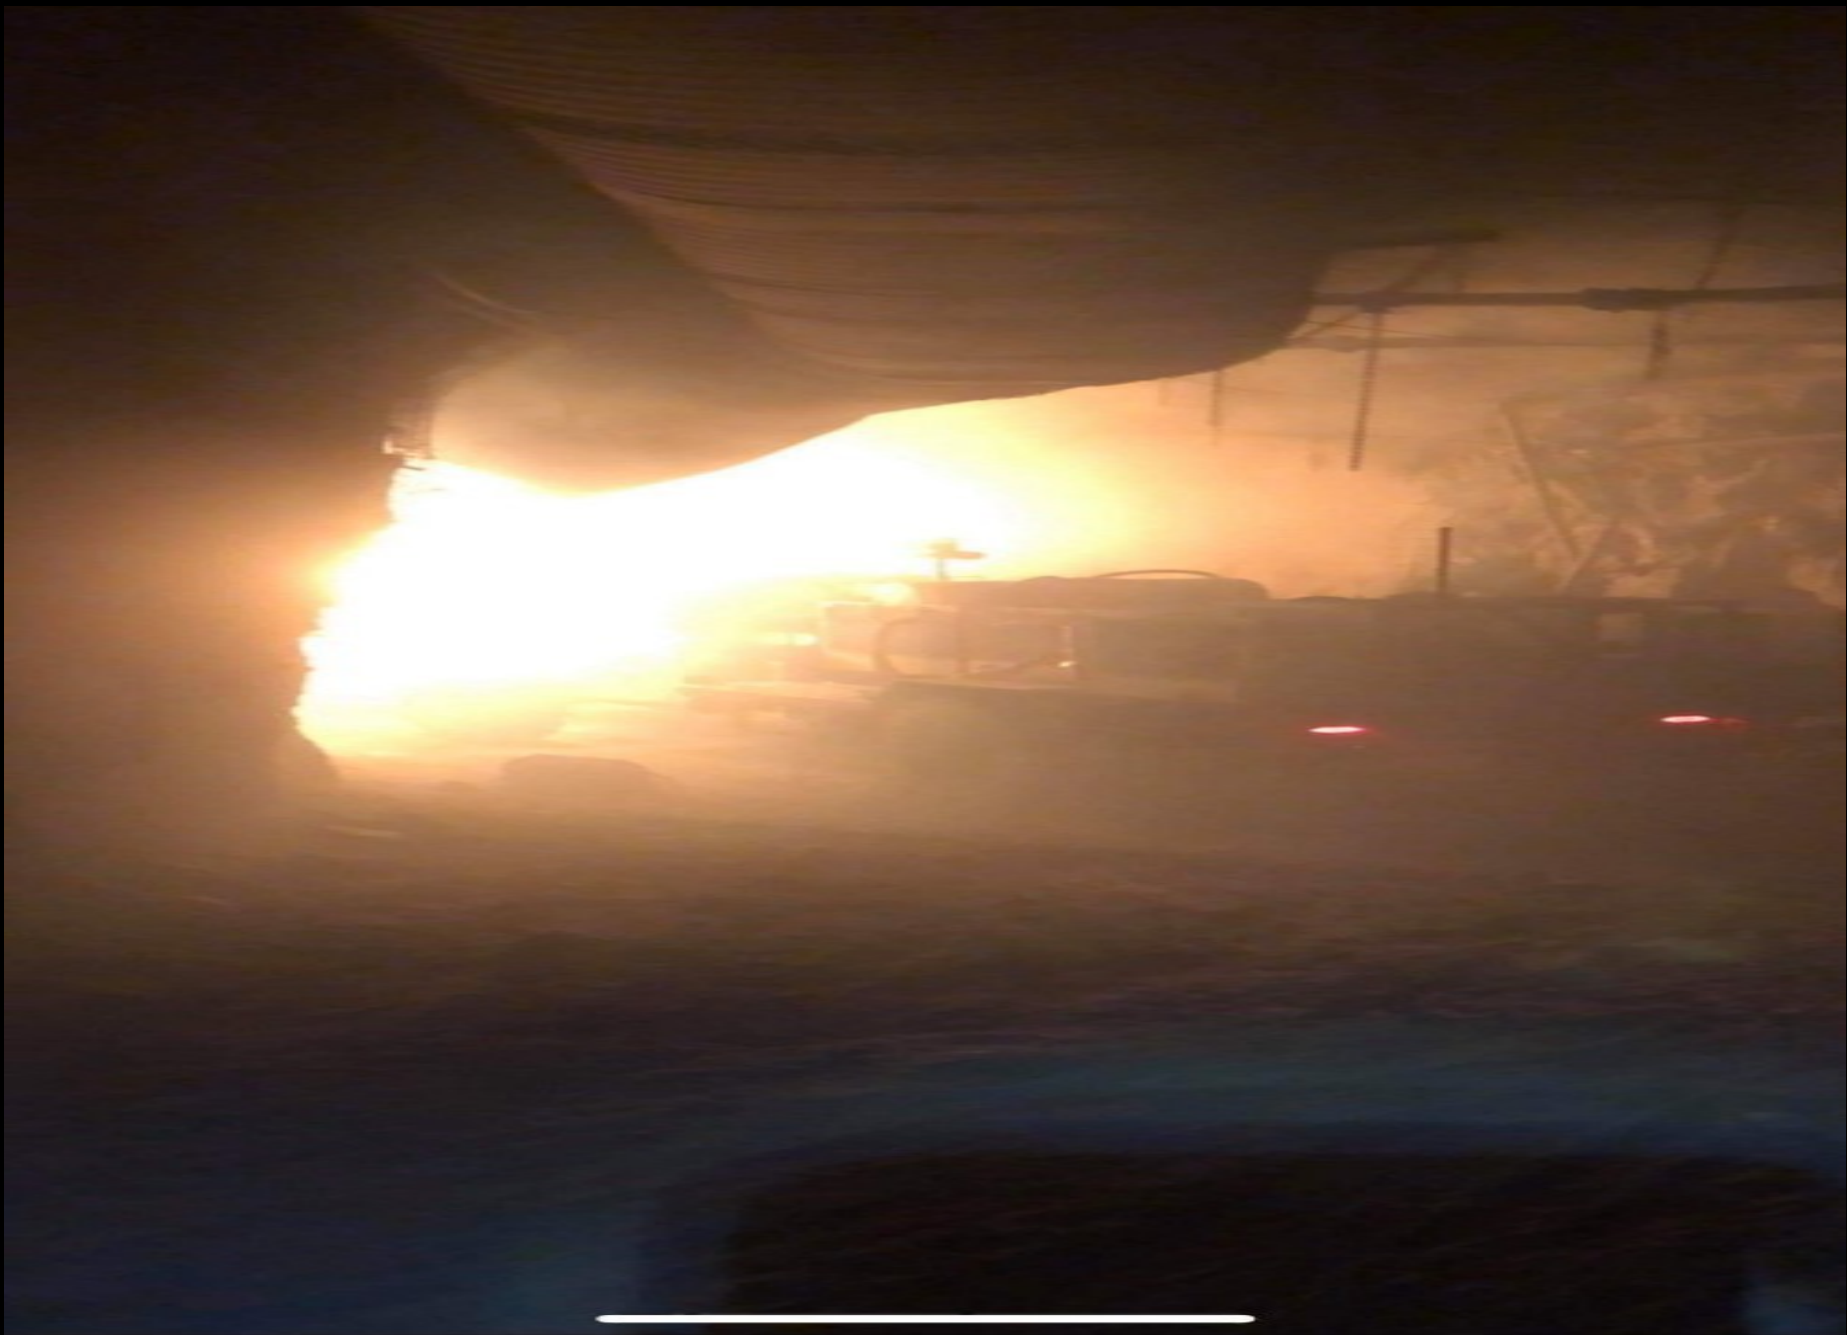
Incident #2 (Sudbury/Onaping District)

- July 6, 2020 @ approximately 10:50pm
- Initial Fire was reported by two contractors working on an electric boom truck.
- Information was received through brief contact with workers who reported that they had no compressed air and were trapped behind the vehicle on fire.
- Within minutes of initial contact, no further communication with the two contractors could be established.

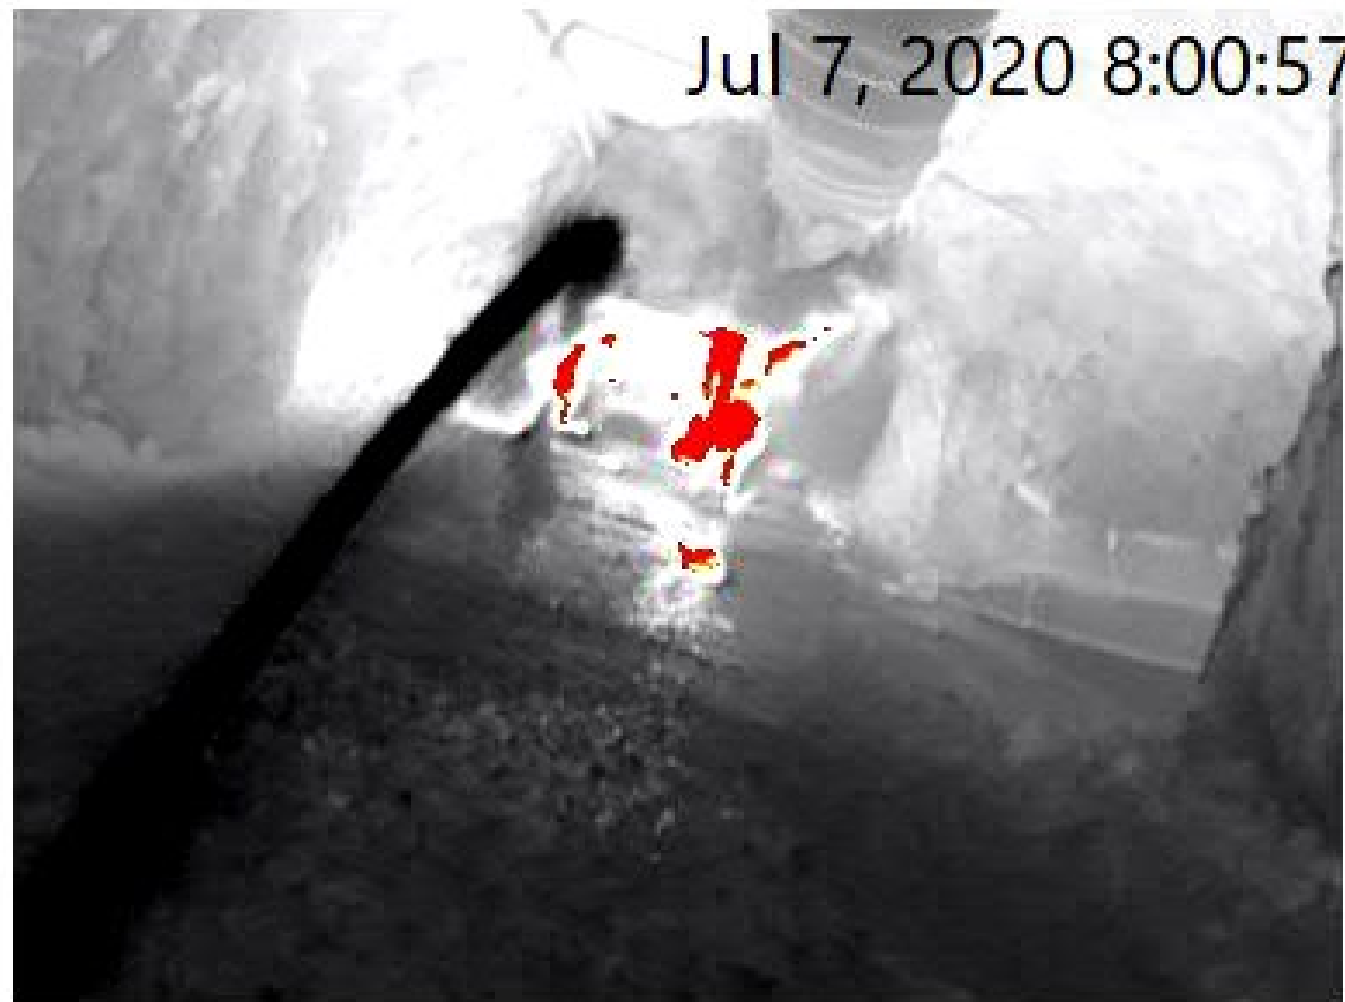
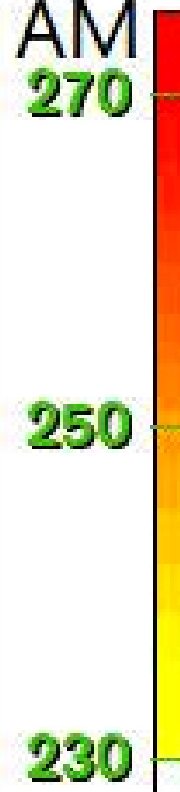
- Emergency procedures were implemented soon after
- Team #1 went underground at around 0100 hrs and encountered the fire scene at 01:55 hrs.
- Dark black smoke and extreme heat were encountered at the area. (700F recorded with TIC)
- Communication was affected and could not be established at the work site.

164°F

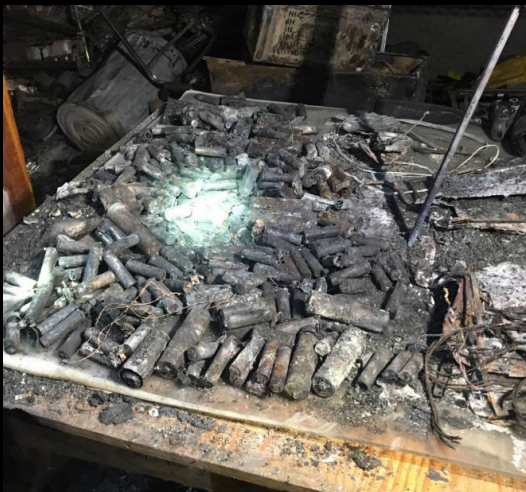
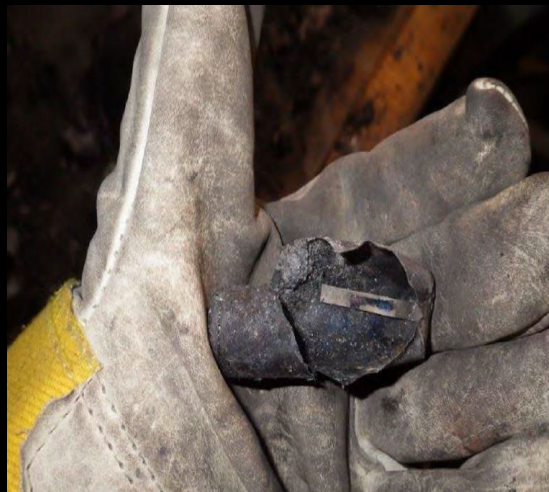
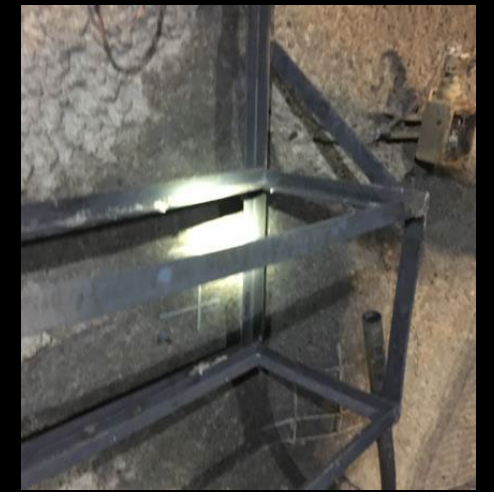
Incident #3 (Red Lake District)

- June 12, 2018
- Incidents occurred between shifts, and was discovered by nightshift, in U/G shop, shelving unit containing batteries and charging unit.
- The fire started on the top shelf, which burned through the second shelf which also contained lithium ion batteries. The engulfed shelving and batteries fell to the ground and continued to burn.

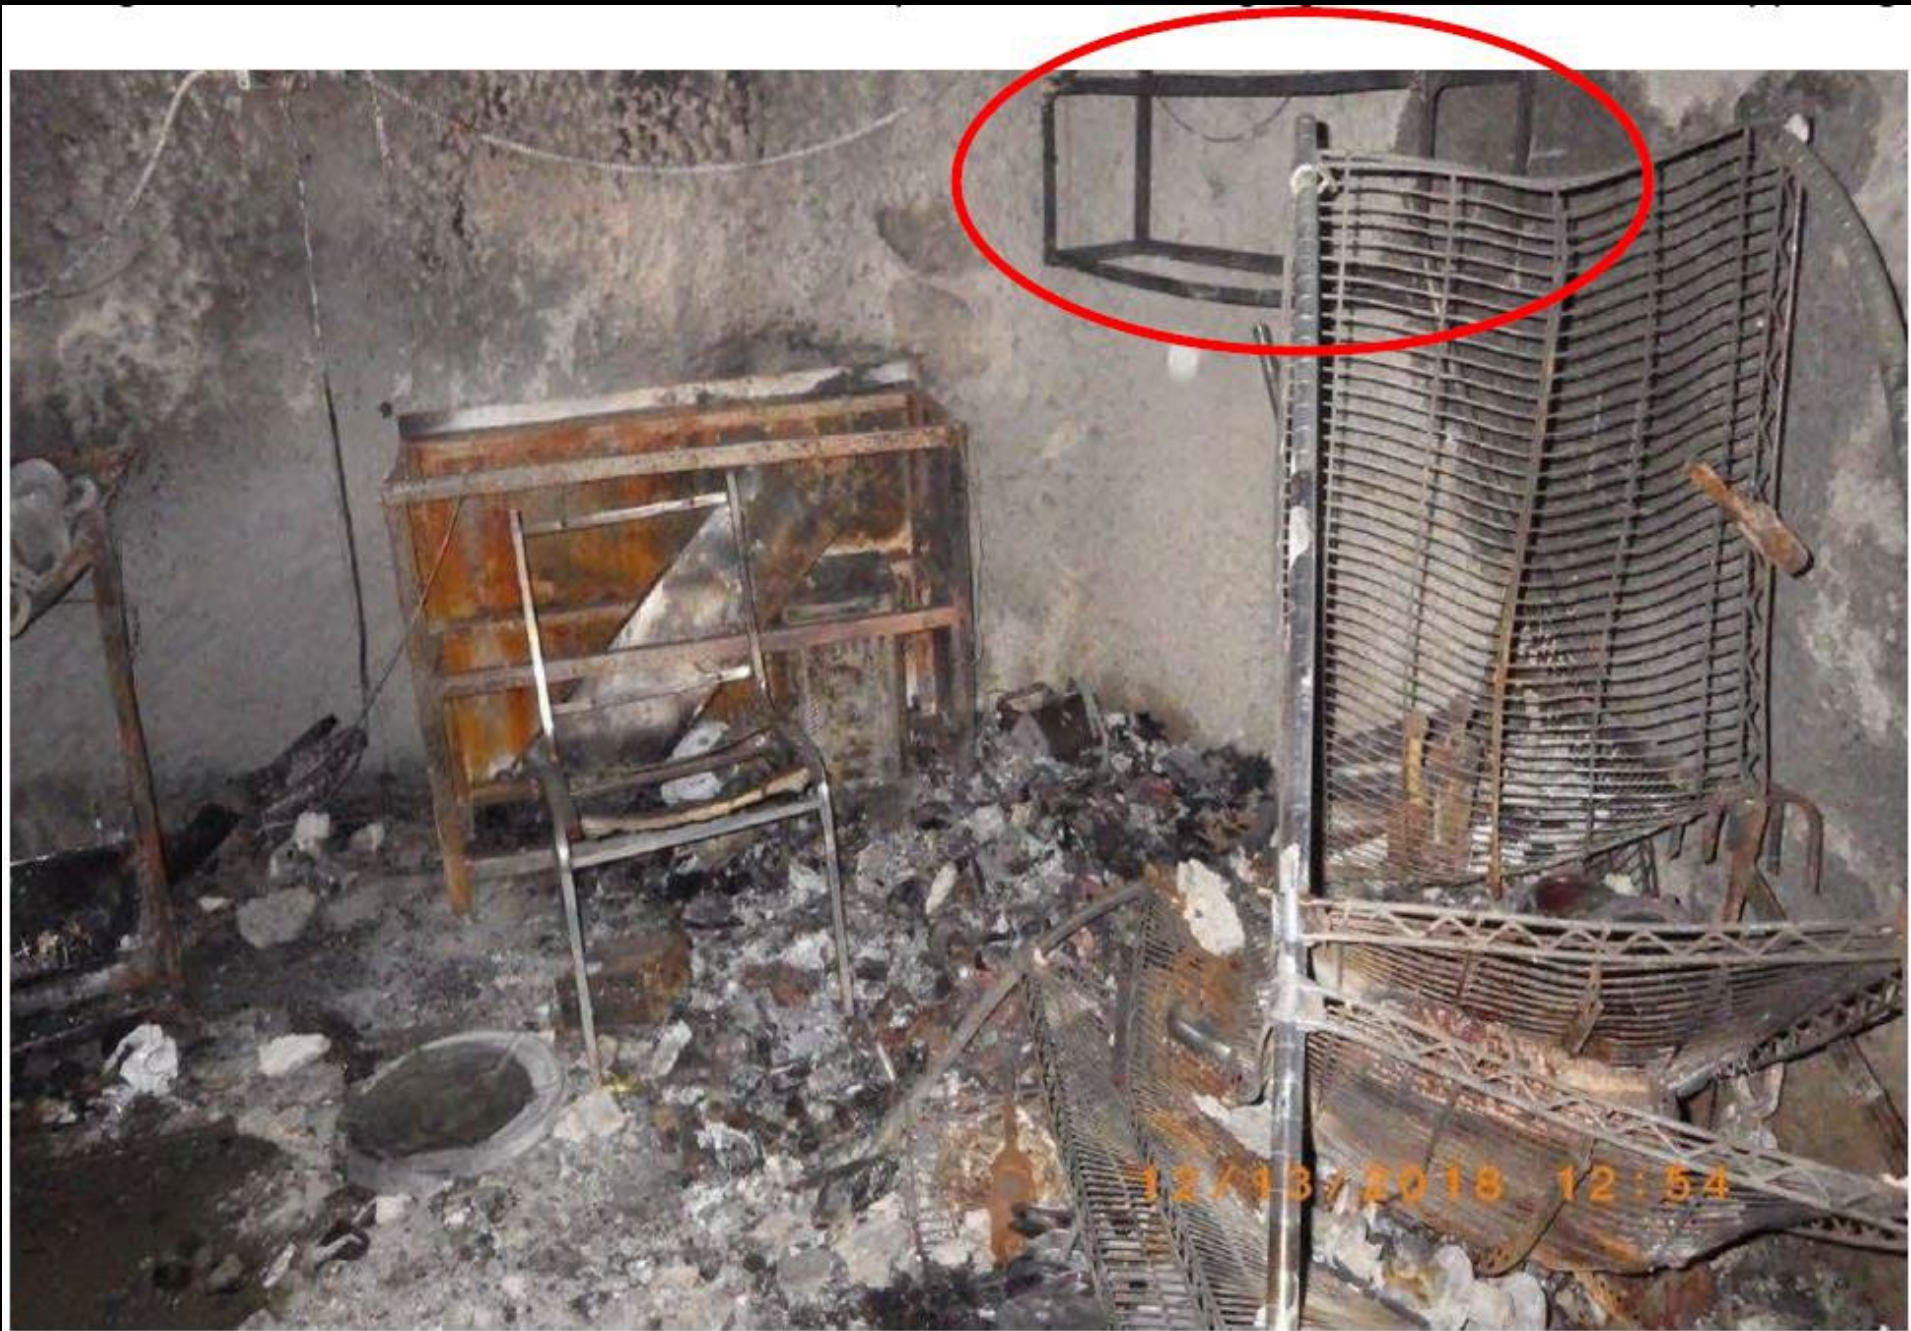
- At 21:05 hrs Team #1 travelled U/G to investigate fire.
- Team arrived at the scene and encountered rechargeable batteries on fire.
- Fire extinguishers were used, and fire was reported out at 22:09 hrs.
- Team #1 remained on fire watch until 23:40 hrs.
- Team #2 travelled U/G and continued fire watch until 02:17 hrs.
- Investigation deemed that a battery charging station failed, and caught fire. (Approximately 30 18v batteries involved)
