Raise Overhead Protection Design and Certification

WSN Health and Safety Conference
Sudbury Ontario
April 2016

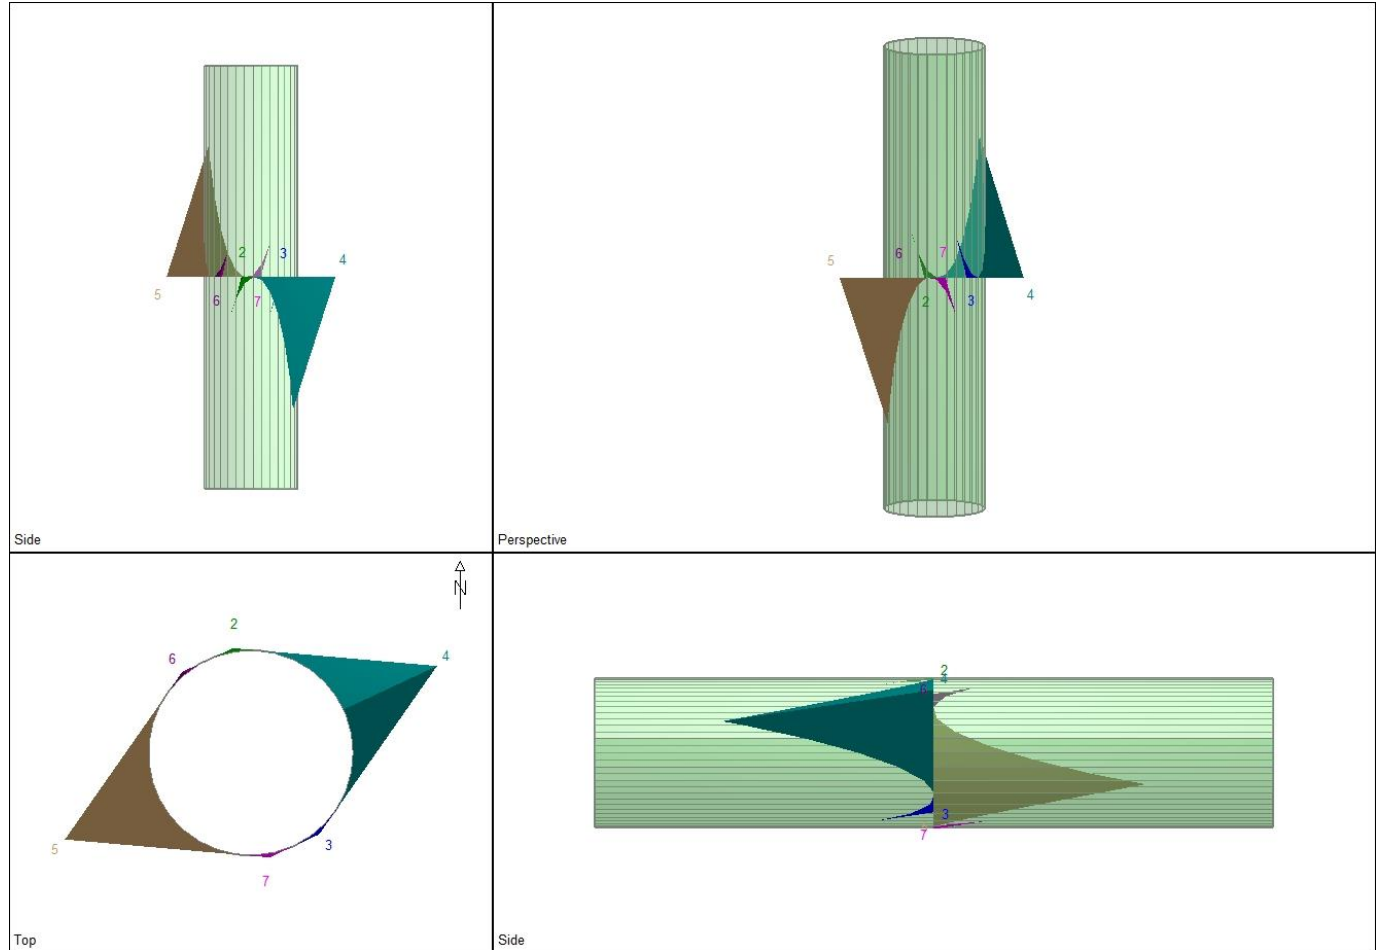
Wedge Analysis – 42”φ

Wedge Information

Wedge Weight: 0.251 tonnes

Factor of Safety: 0.315

Wedge Weight: 0.250 tonnes

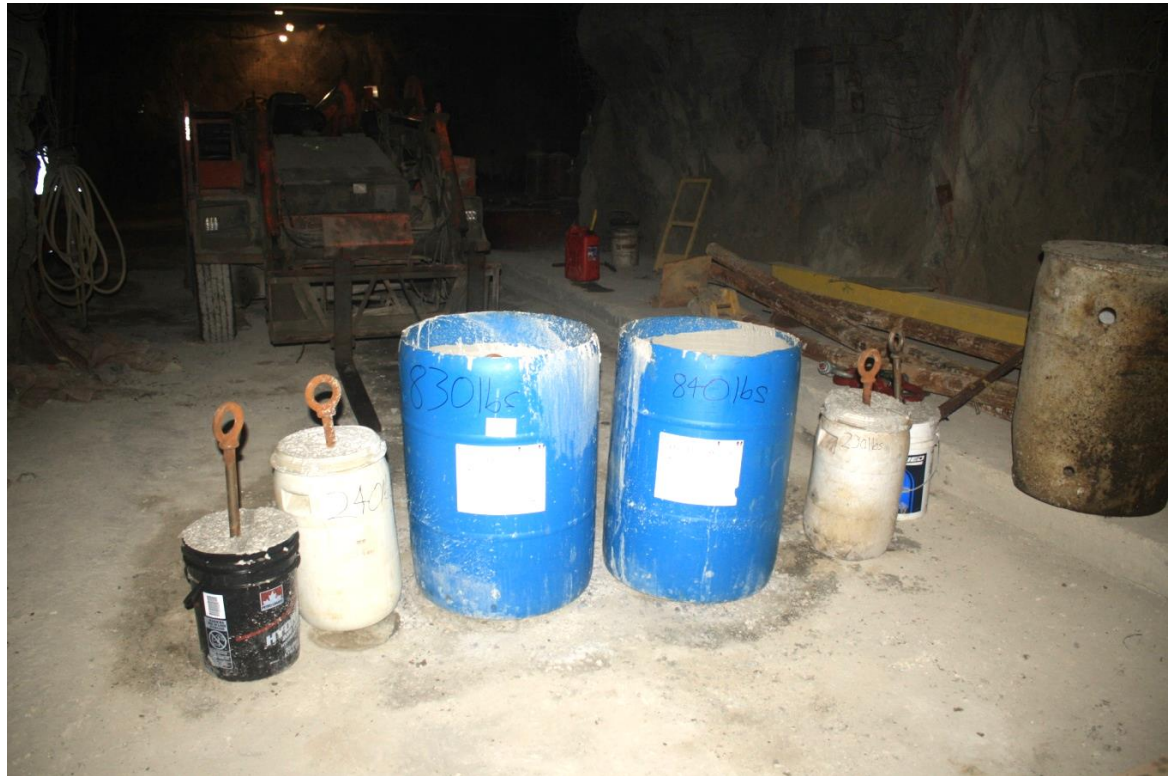
Weights

- Six test weights manufactured using 20, 40, and 205 litre pails/drums filled with concrete, and equipped with lifting eyes
- **Weights**
 - 830-840 lbs
 - 230-240 lbs
 - 140 lbs
- **Simulate range of impact energies of rock wedges anticipated to fail from raises of various diameters**
- **By adjusting height from which weights are dropped, the actual impact energy can be modified**

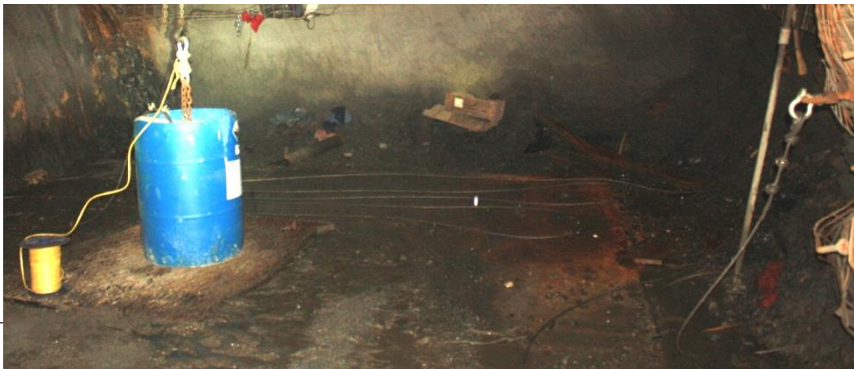
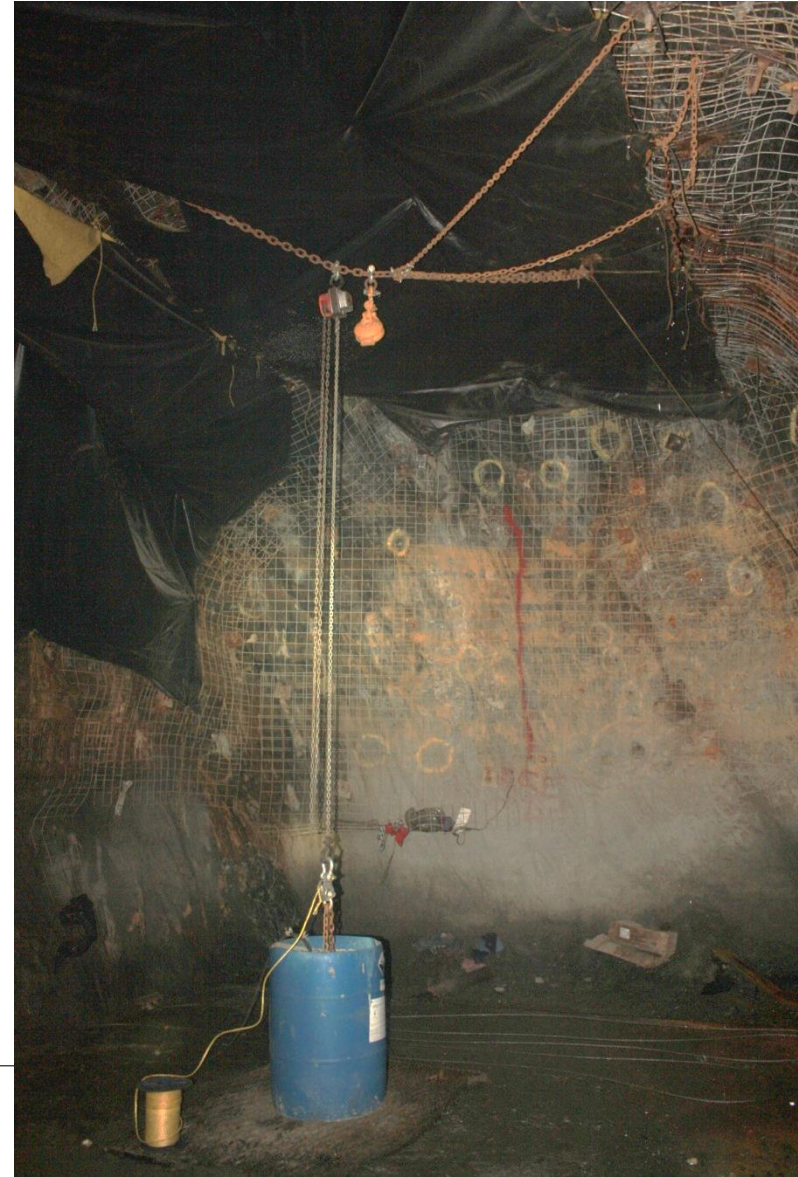
Test Setup

- **Weight suspended over open raise from a chain fall to allow drop height to be adjusted**
- **Quick release hook to allow weight to be dropped without exposing personnel**
- **Safety line to retrieve weight from within the raise if the bulkhead works, and to prevent the weight from travelling large distance in the undercut if the bulkhead fails**

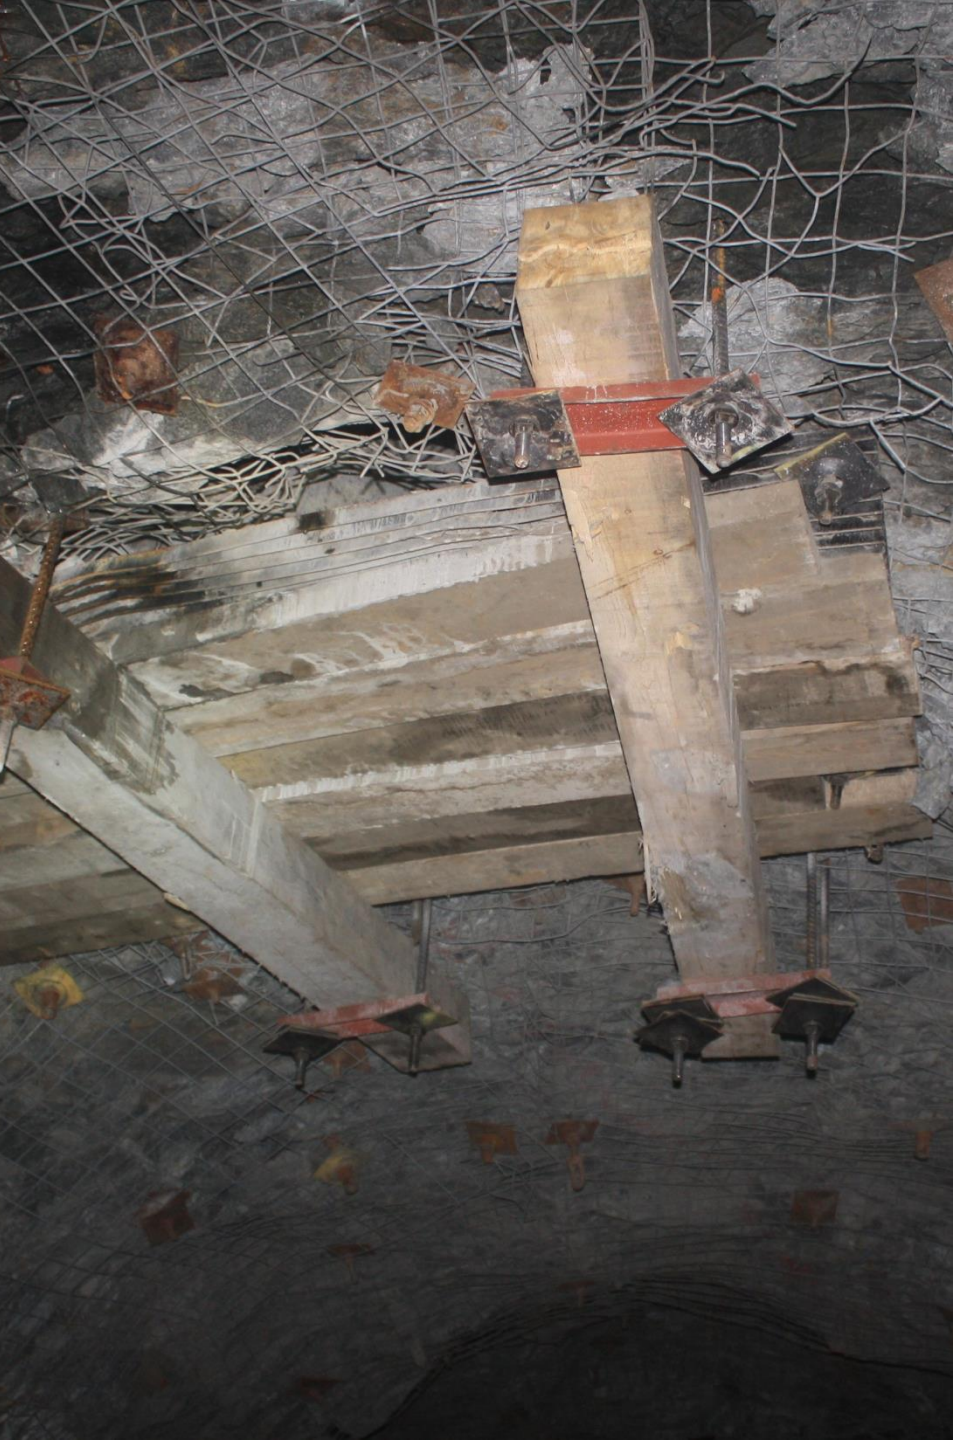
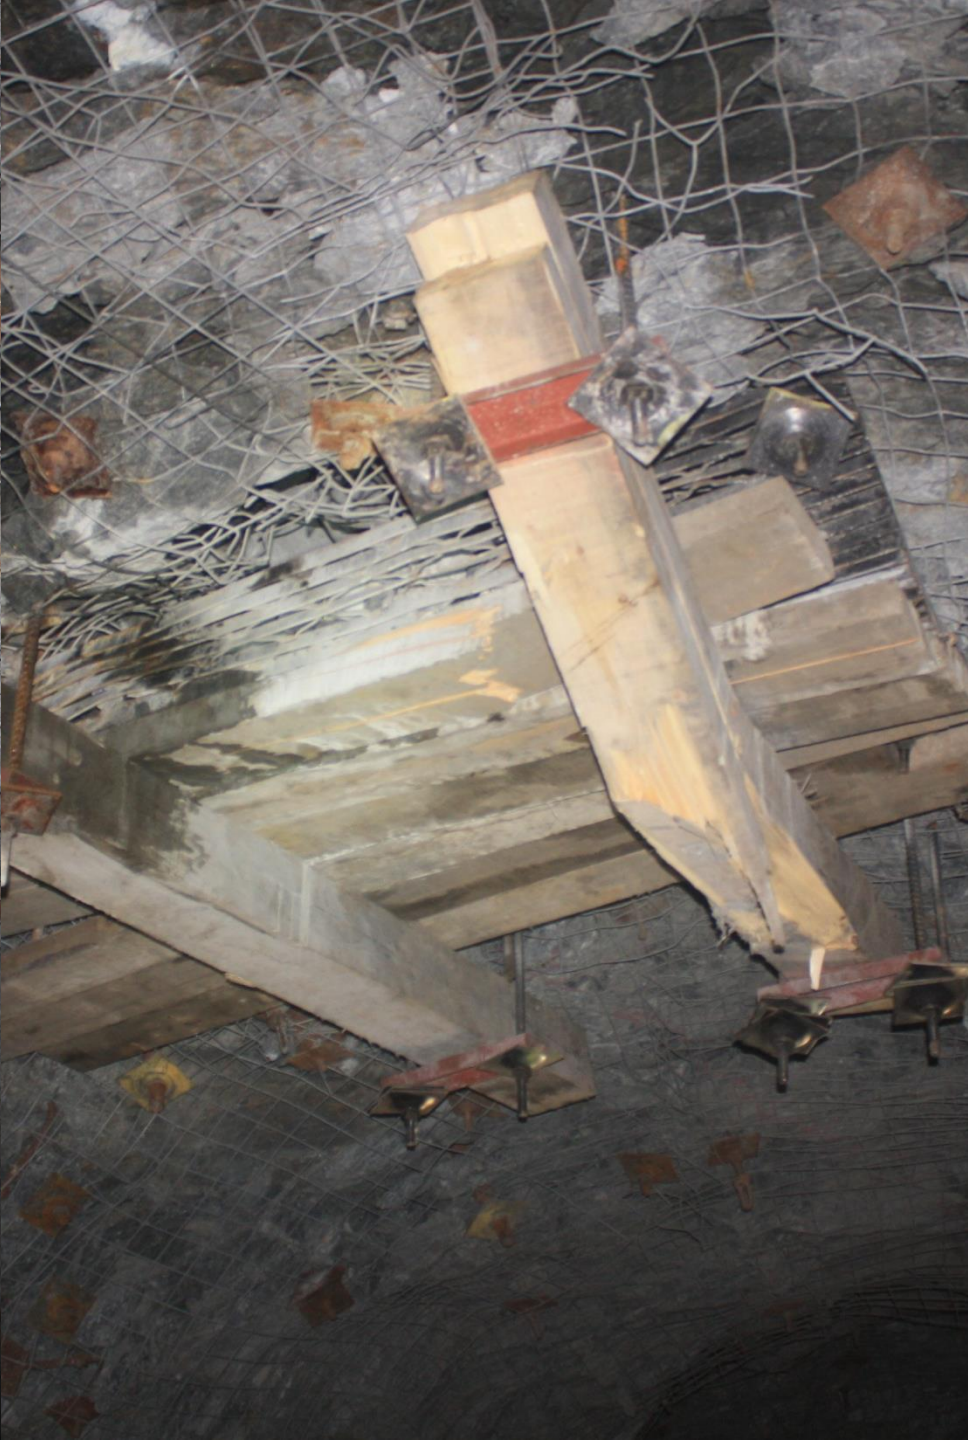
Existing Cover Testing

- **Test weights dropped down two raises on conventional and modified grating based bulkheads**
- **The conventional bulkhead tested was “selected at random” and no special effort was made to ensure the installed bulkhead was in total agreement with the original design drawings**
- **The timber contained defects which were only discovered at the time the test was being done, therefore this represented a “worst case” scenario**
- **The bulkhead was tested using a 240 lb weight, dropped through a distance of 35 meters, which represented the worst case scenario for the maximum mass in a 0.76 m diameter raise**

- **Cover suffered failure of either bolts or timber**
- **Underlying cause was the welded steel grating was too stiff, and could not transfer or dissipate energy, resulting in shock loading of support elements**
- **Timber unable to “flex” rapidly, and flexure was beyond the allowable extreme fibre bending stress, resulting in ejection of splinters which could cause injury**

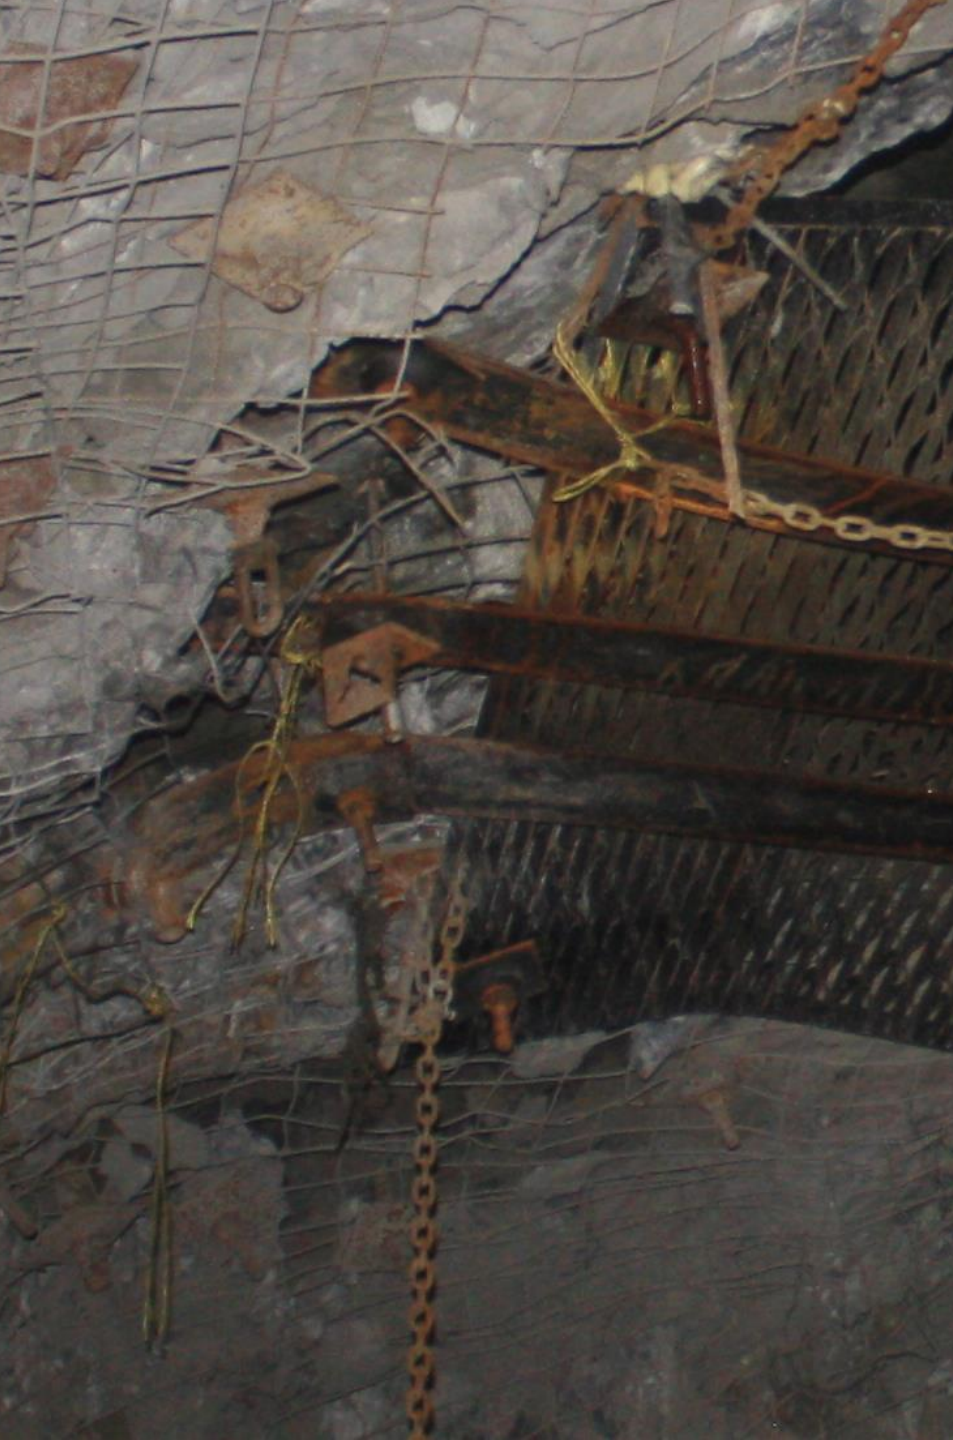
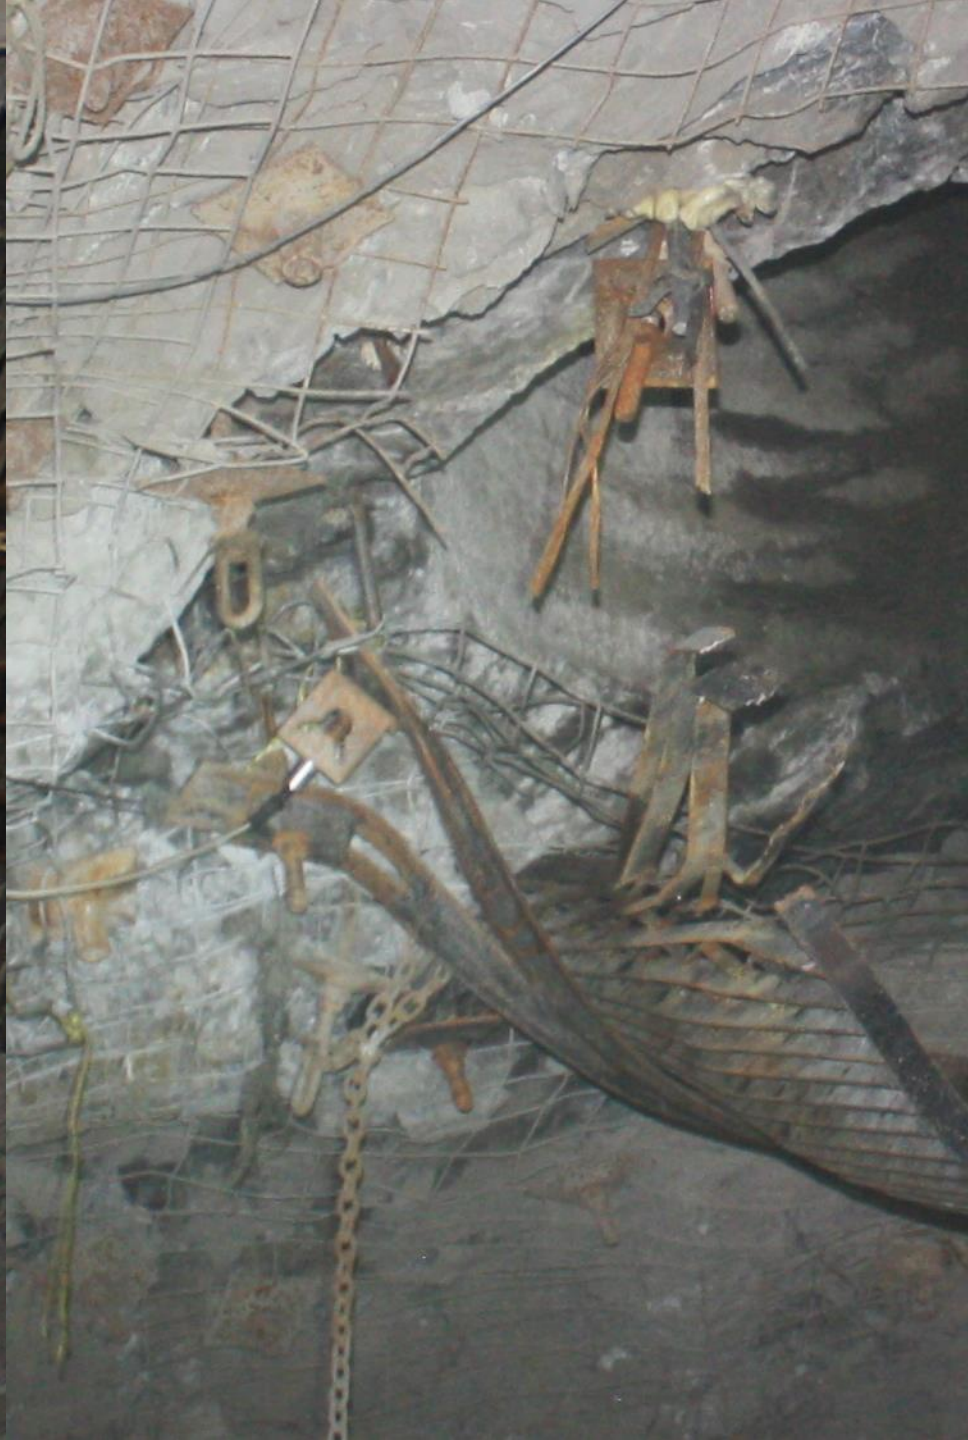
Modified Cover Testing

- The timber was seen to be a “weak link” from the first test
- Timber replaced by heavy gauge flat bar straps, to test the hypothesis that the straps would provide much more flexibility, and be better able to deform
- Straps included “slots” to allow the strap to slide relative to the bolts, in order to absorb further energy
- Bolts were instrumented to try to determine the loading on the bolts during or after the impact
- The data logger was incapable of sampling fast enough to obtain the peak impact load, but should be able to determine the final load or deformation

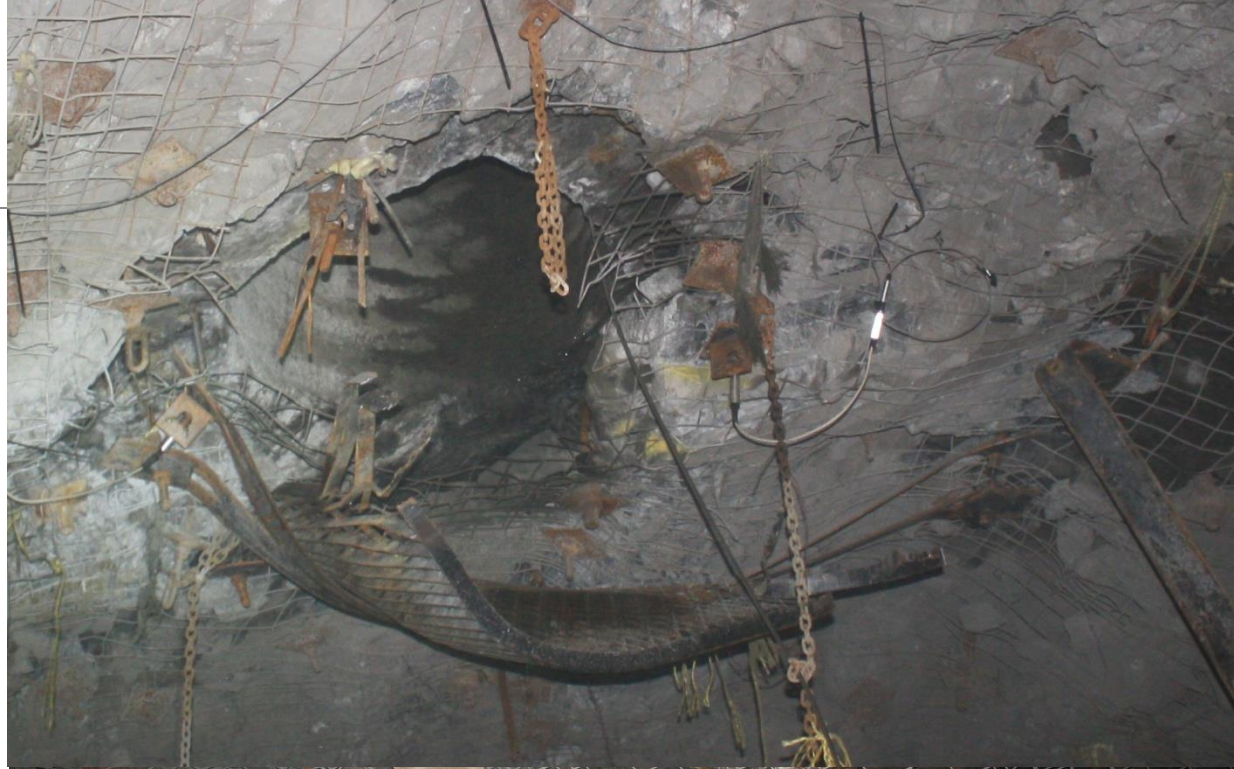
-
- **75-S35 – 381 kg falling 23 m – grating failed at rivets, detached from rebar, overloading single strap**

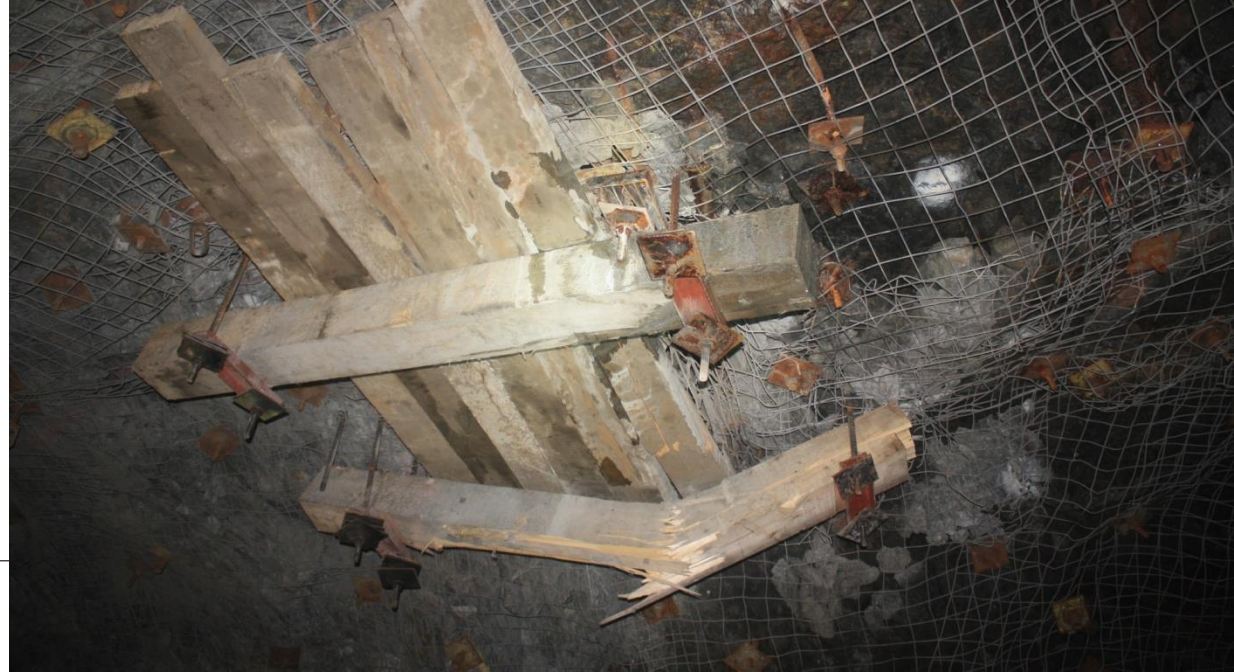
- **94-063 – 108 kg falling 35 m – rapid bending of grating caused timber failure during shock loading**

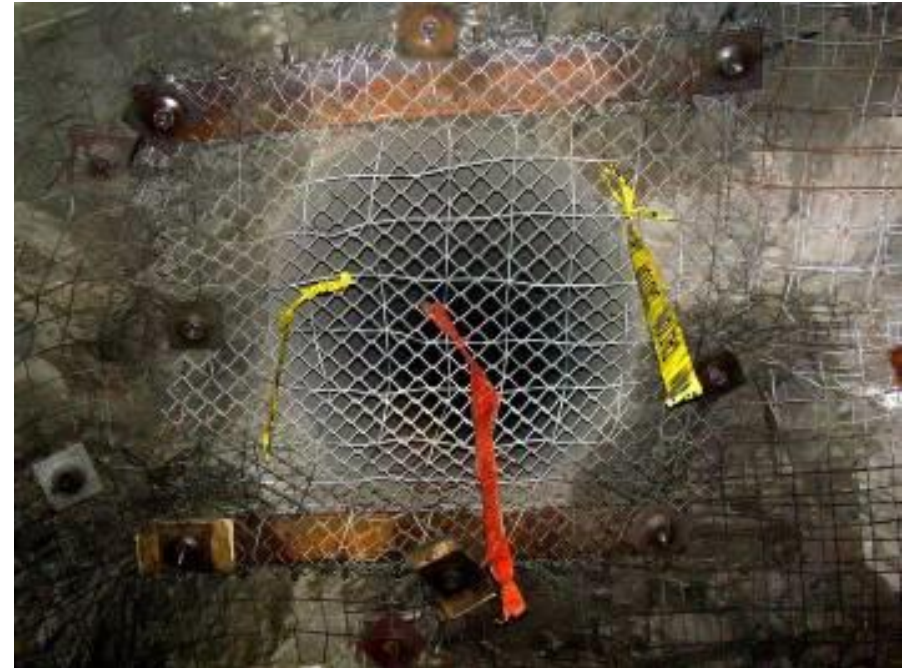
Prototype Cable Laced Mesh Design

- Literature search revealed that an alternate design existed within the “corporate memory” from Brunswick Mine
- Brunswick design was insufficient for Kidd operating specifications – design was based on shorter smaller diameter raises, smaller wedge mass and lower impact energy
- Brunswick design also showed evidence of failure of both cable and mesh under lower impact load during the initial certification testing
- The serrated strap used to restrain the mesh had “sharp contacts” and high point loads, which caused the mesh to fail where it was highly confined and unable to yield

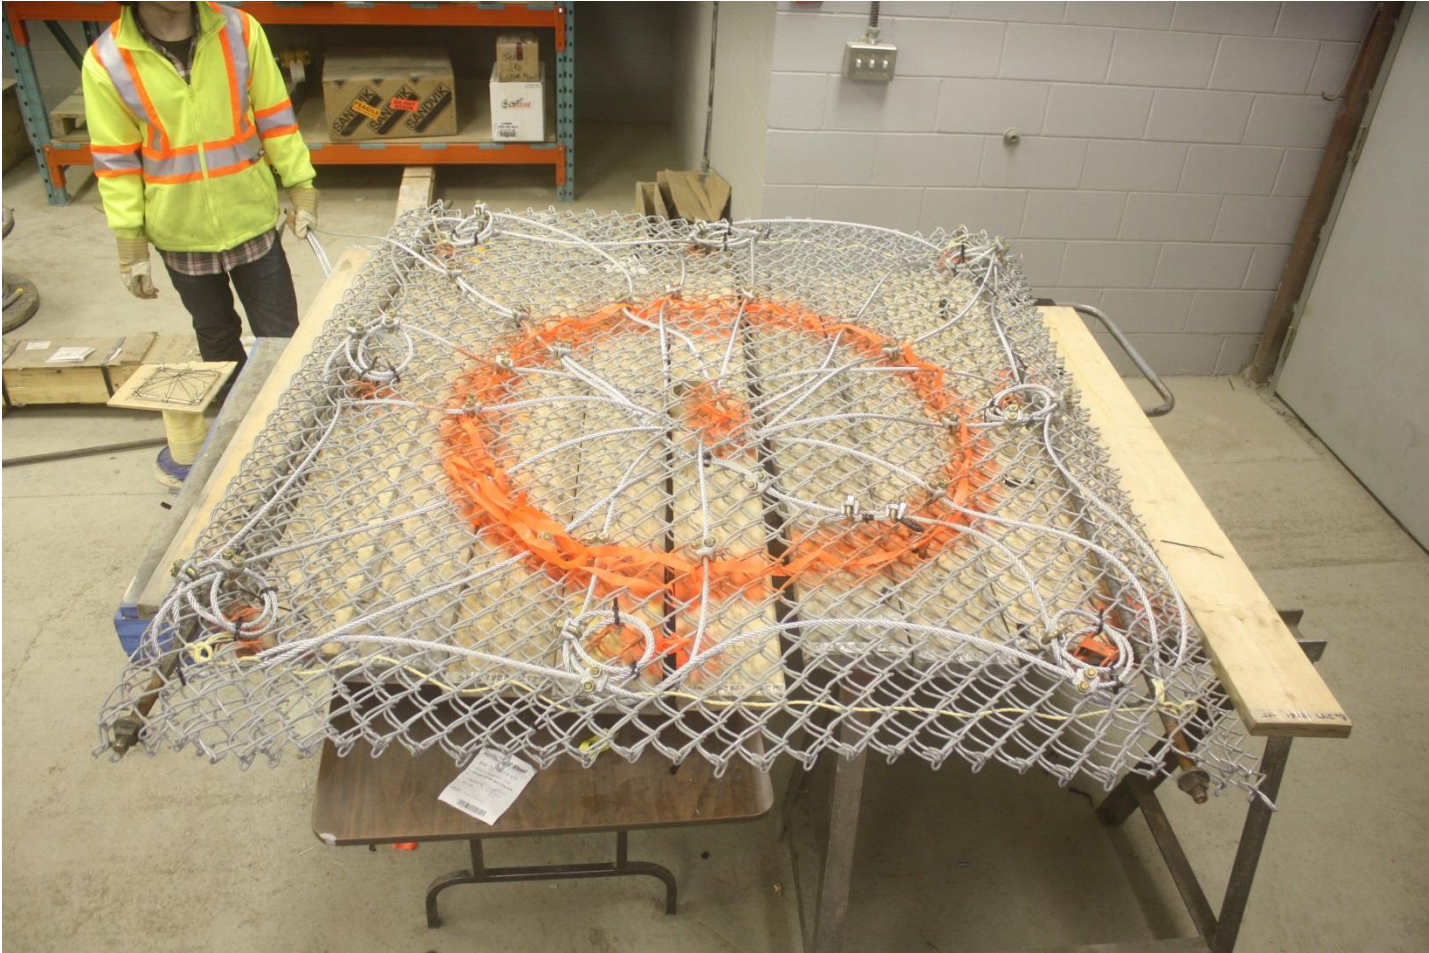
Prototype Cable Laced Mesh Bulkhead under construction

- **Double the mesh to compensate for the failure observed in the Brunswick design report**
- **Change the method of weaving the cables through the mesh to increase the yield and strain capacity of the cables**
- **Provide “shock” capacity in the cables to allow them to slip before they created high loading on the supporting members**
- **Remove any “sharp contacts” in the system between the cables, the mesh and the bolts, to reduce the risk of the “guillotine” failure seen with the second “modified” bulkhead design at Kidd, and the Brunswick design report, where the serrated strap edge was seen to cut both the mesh wires, and the reinforcing cables**

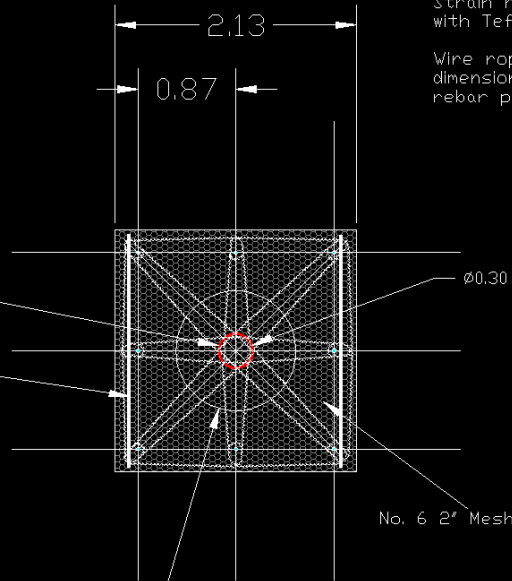
Fabrication and Installation Layouts

One strain relief loop per "diameter" of cable, after crossing centre of bulkhead, formed by looping wire rope around pin prior to weaving through mesh along perimeter. Strain relief loop to be affixed in place with Crosby clips, with Teflon lock nuts.

Wire ropes to be tie-wrapped to mesh, to maintain loop dimensions such that they will lay fully under standard rebar plates, during installation underground.

Wire ropes pass to alternate side of mesh within 0.3 m circle

Wire rope to be woven through mesh along outer perimeter of bulkhead, and around rebar

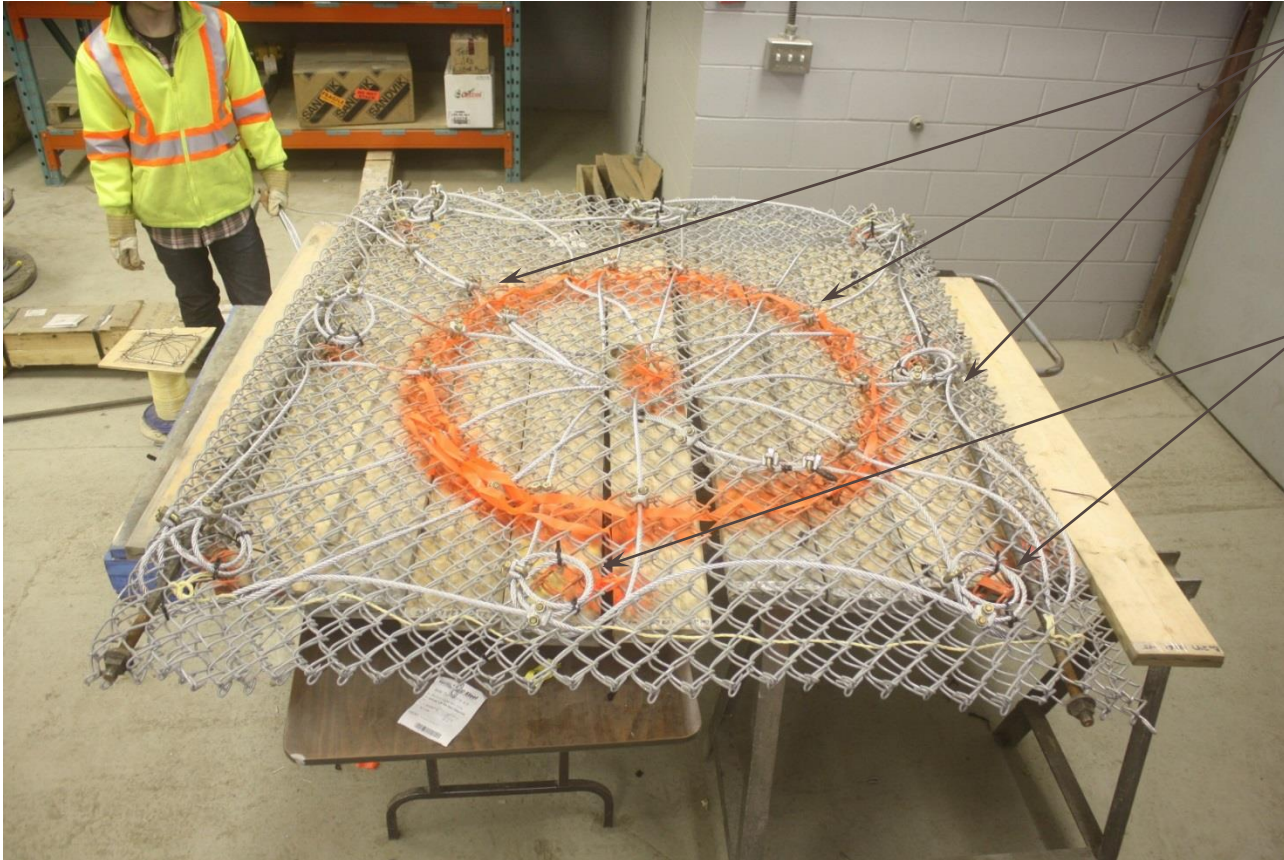
Prototype Cable Laced Mesh Bulkhead under construction

Note Crosby clips tying rope to mesh in multiple locations

Note tightly coiled strain relief loops intended to encircle bolts at installation

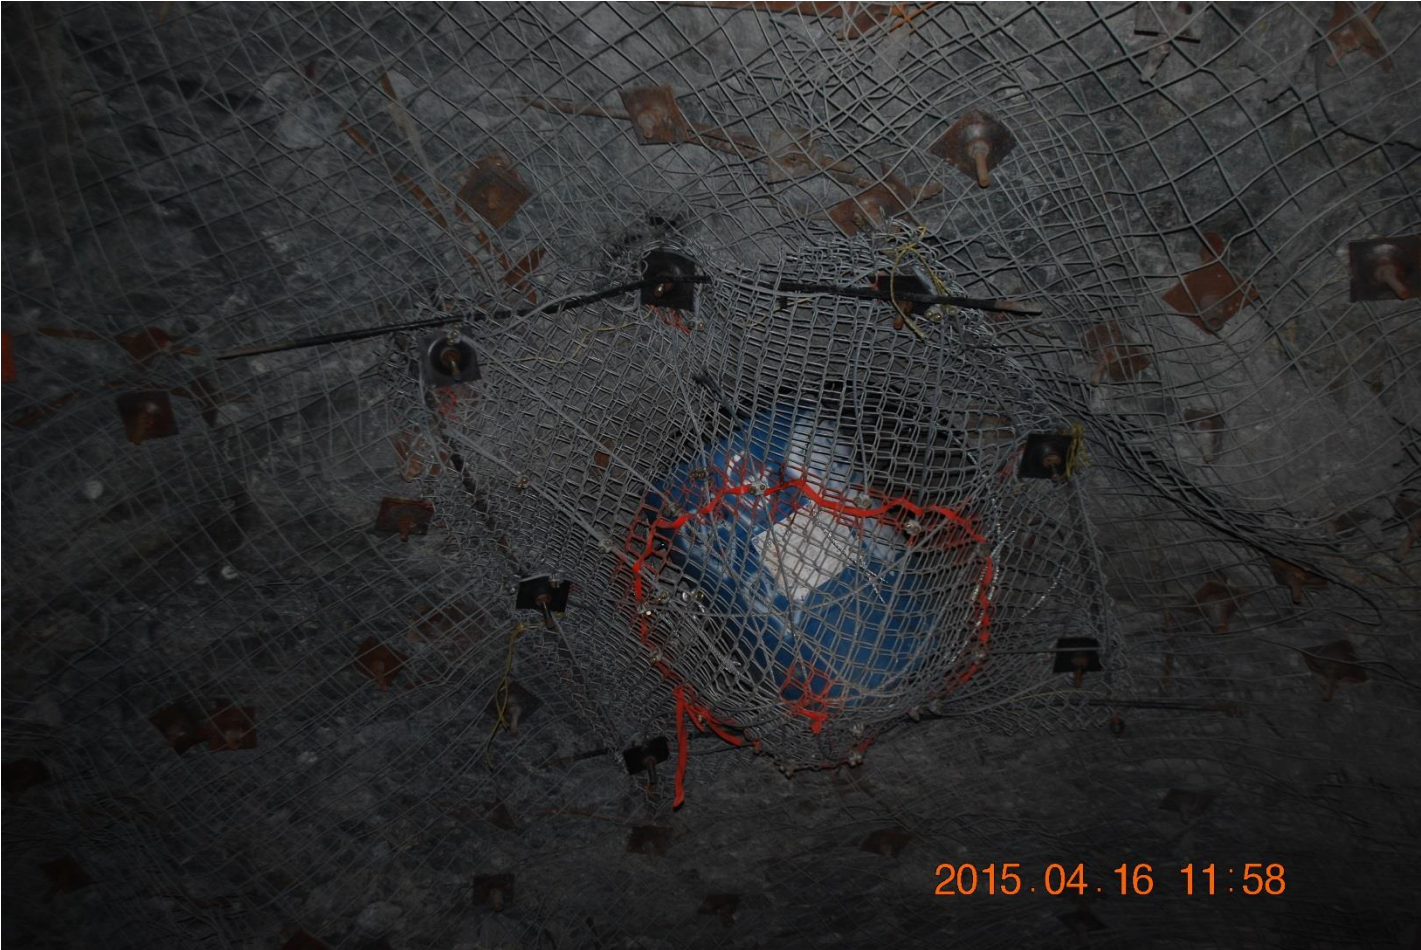
87-086 Bulkhead after impact of 381 kg mass, falling 20 m

- **Wire mesh did not tear at any location, and was successfully reinforced by cables**
- **D bolts stretched, but did not break**
- **Several cables broke due to restricted ability to slip caused by excessive number of Crosby clips**
- **Final impact load was in excess of 535 kN or 120,000 lbs force**
- **Equal to design load of 250 kg (maximum wedge), falling 35 m, with potential energy of 85.5 kJ, coming to stop within 0.16 m only through displacement of bolts, with FOS of 3.75**

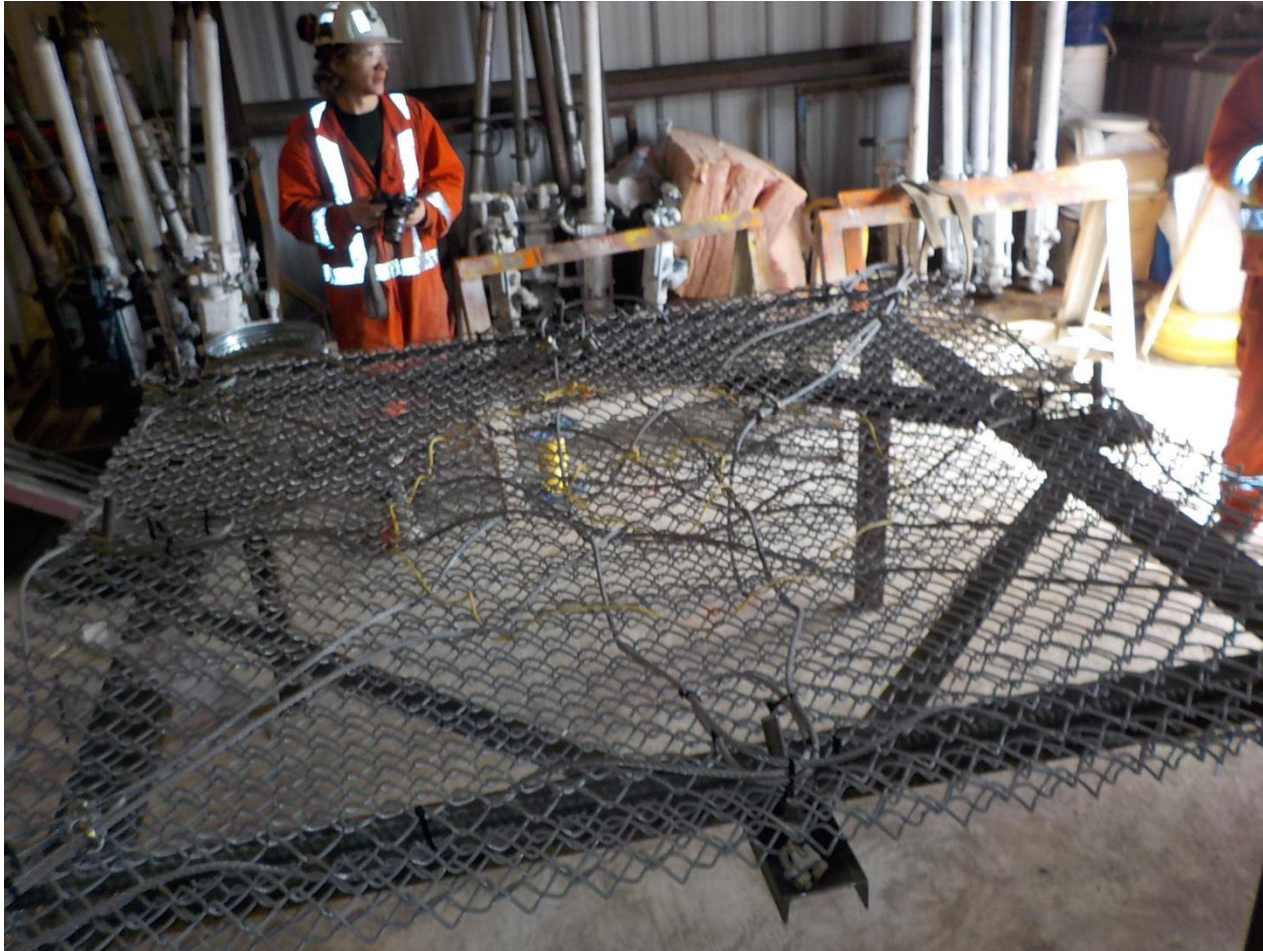
Bulkhead on Prototype Assembly Jig

- **Jig table to pivot vertically to reduce strain on workers during assembly process**
- **Strain relief loops to be elongated to provide more “slip” capacity, coupled with revised torqueing procedure for Crosby clips**
- **Crosby clips to include Teflon lock nuts, to prevent nuts loosening prior to installation**

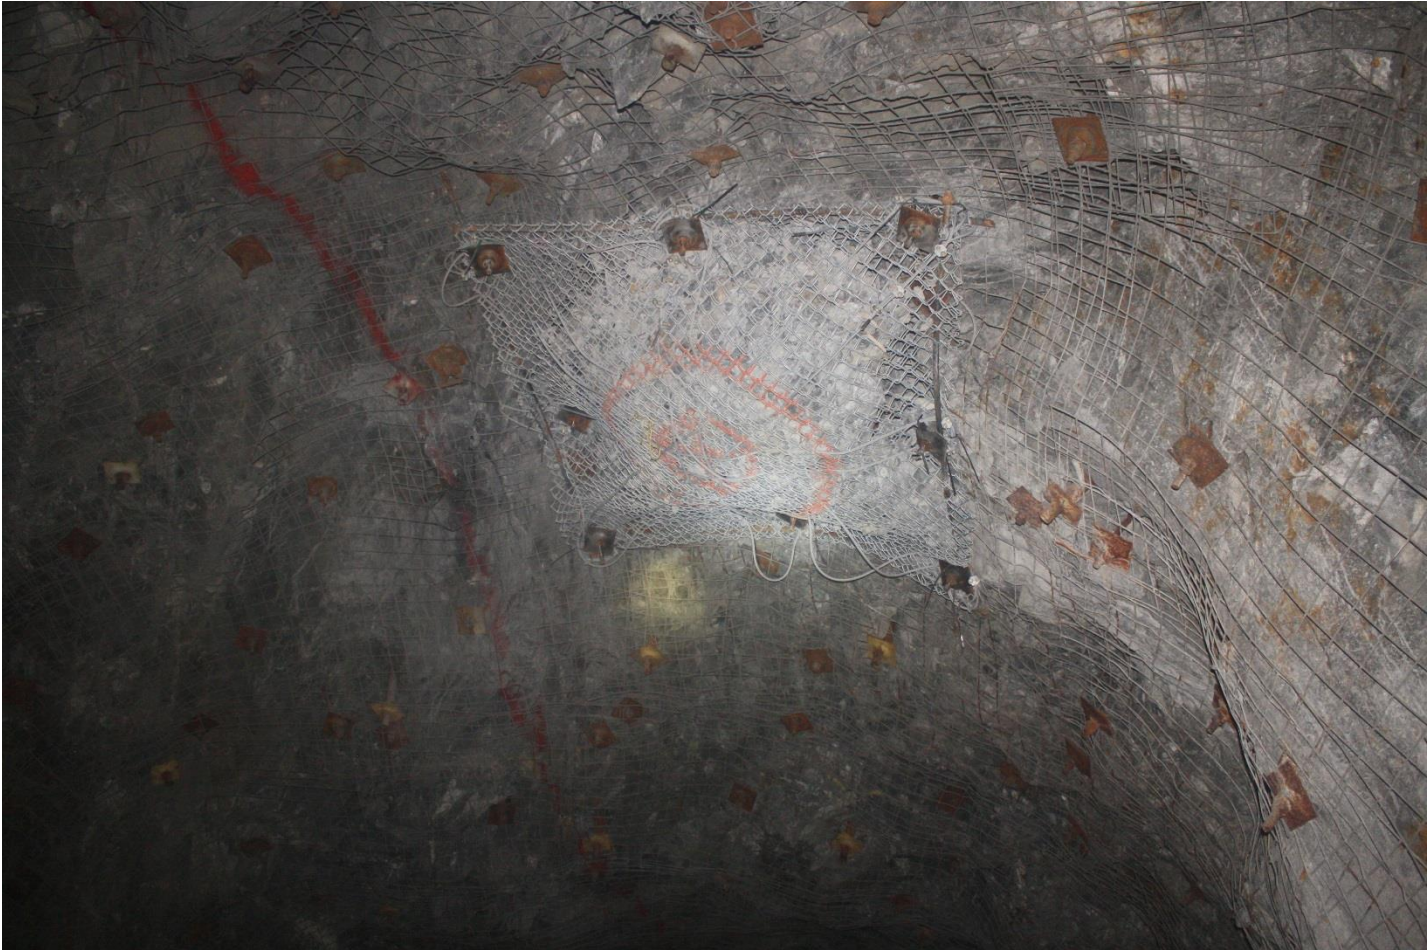
Proof

- **New bulkhead installed in the 95-164 Stope, where uphole drilling had to be done near the raise**
- **Scoop doing cleanup on the overcut lifted the “grating top cover” and inadvertently dumped in excess of 2 cubic meters of muck down the raise**
