# Macassa Mine Battery Fires Summary

February 15, 2024

The following presentation will detail a summary of battery fires experienced at our Macassa operation.

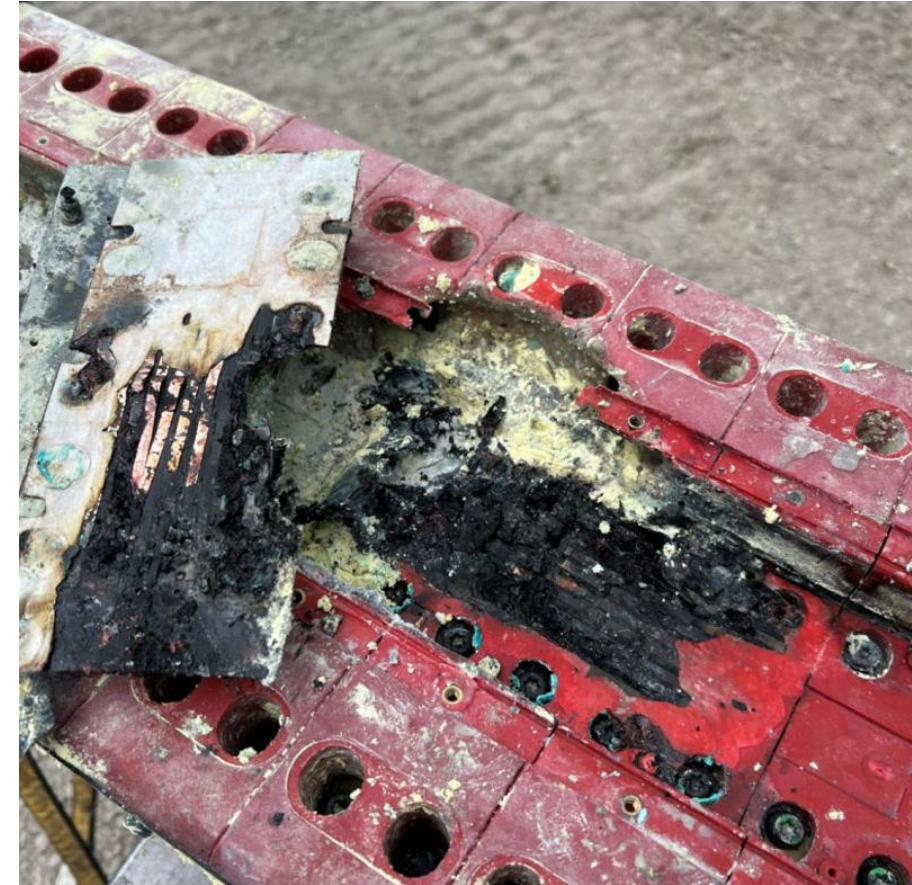
The morning of July 17<sup>th</sup> at approx. 7:00 a.m., a call was received about a Z40/50 module that was observed emitting smoke. This module was part of the work that was completed on July 15<sup>th</sup>.

Upon arrival to investigate, heavy smoke was noticed coming from the module. The module top was observed to be heavily melted around the CM board area of the module. The surface loader operator was instructed to bring over a large tote of water so the module could be submerged to stop the thermal process. While waiting for the tote, a small flame was noticed in the CM board location of the module.

Module was then fully submerged in the tote. At this time, a second module was noticed to have started emitting smoke. No open flame was observed, but damage due to heat was also noticed in the same location as the first module. Around the CM board location. This module was also submerged to stop the thermal process.

An investigation was completed the afternoon of the 17<sup>th</sup> on the two modules and the cause was found to be tracking under the CM board due to moisture. This led to the module itself shorting out.

Actions taken were to remove the module tops that house the CM board and Flex tape circuit which also would remove the buss bars from the individual cells further isolating them down to individual cell voltages of ~3.6 volts. The modules with the “module tops” removed have been wrapped in plastic to keep water from entering.

The Z40/50 modules were prioritized to be completed first as they were identified to have the highest risk due to design and all modules have been completed on this style.
