Incident Summary

Onaping Depth BEV Fire

2020-07-06

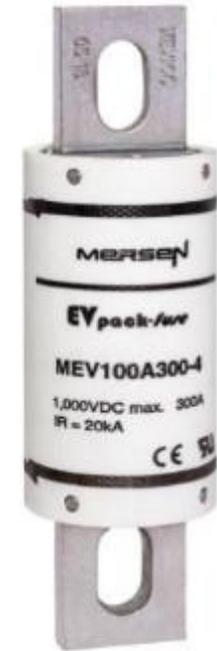
Figure 13 – Example of Fuse for EV Use

- Consider specifying that Main fuses/overcurrent protection require a tool to remove or replace. This may help ensure that only authorized persons perform this task.
 - Battery fuses in particular should *never* blow unless a severe fault has occurred. It should not be a “routine” task to replace these – qualified person should be involved.
 - Still need to make sure it is safe for the person to remove/replace the fuses.
- Should ensure that labels are present, indicating make/model/rating of each overcurrent device. This way, it is clear to maintenance personnel what *should* be installed.
- Also need to ensure that the overcurrent protection devices themselves are well marked and easy to identify.
 - A fuse should *look* like a fuse. A circuit breaker should *look* like a circuit breaker. And a copper shunt should *look* like a copper shunt.
