Ontario Mine Rescue

BEV Emergency Response Incident
Review and Best Practices

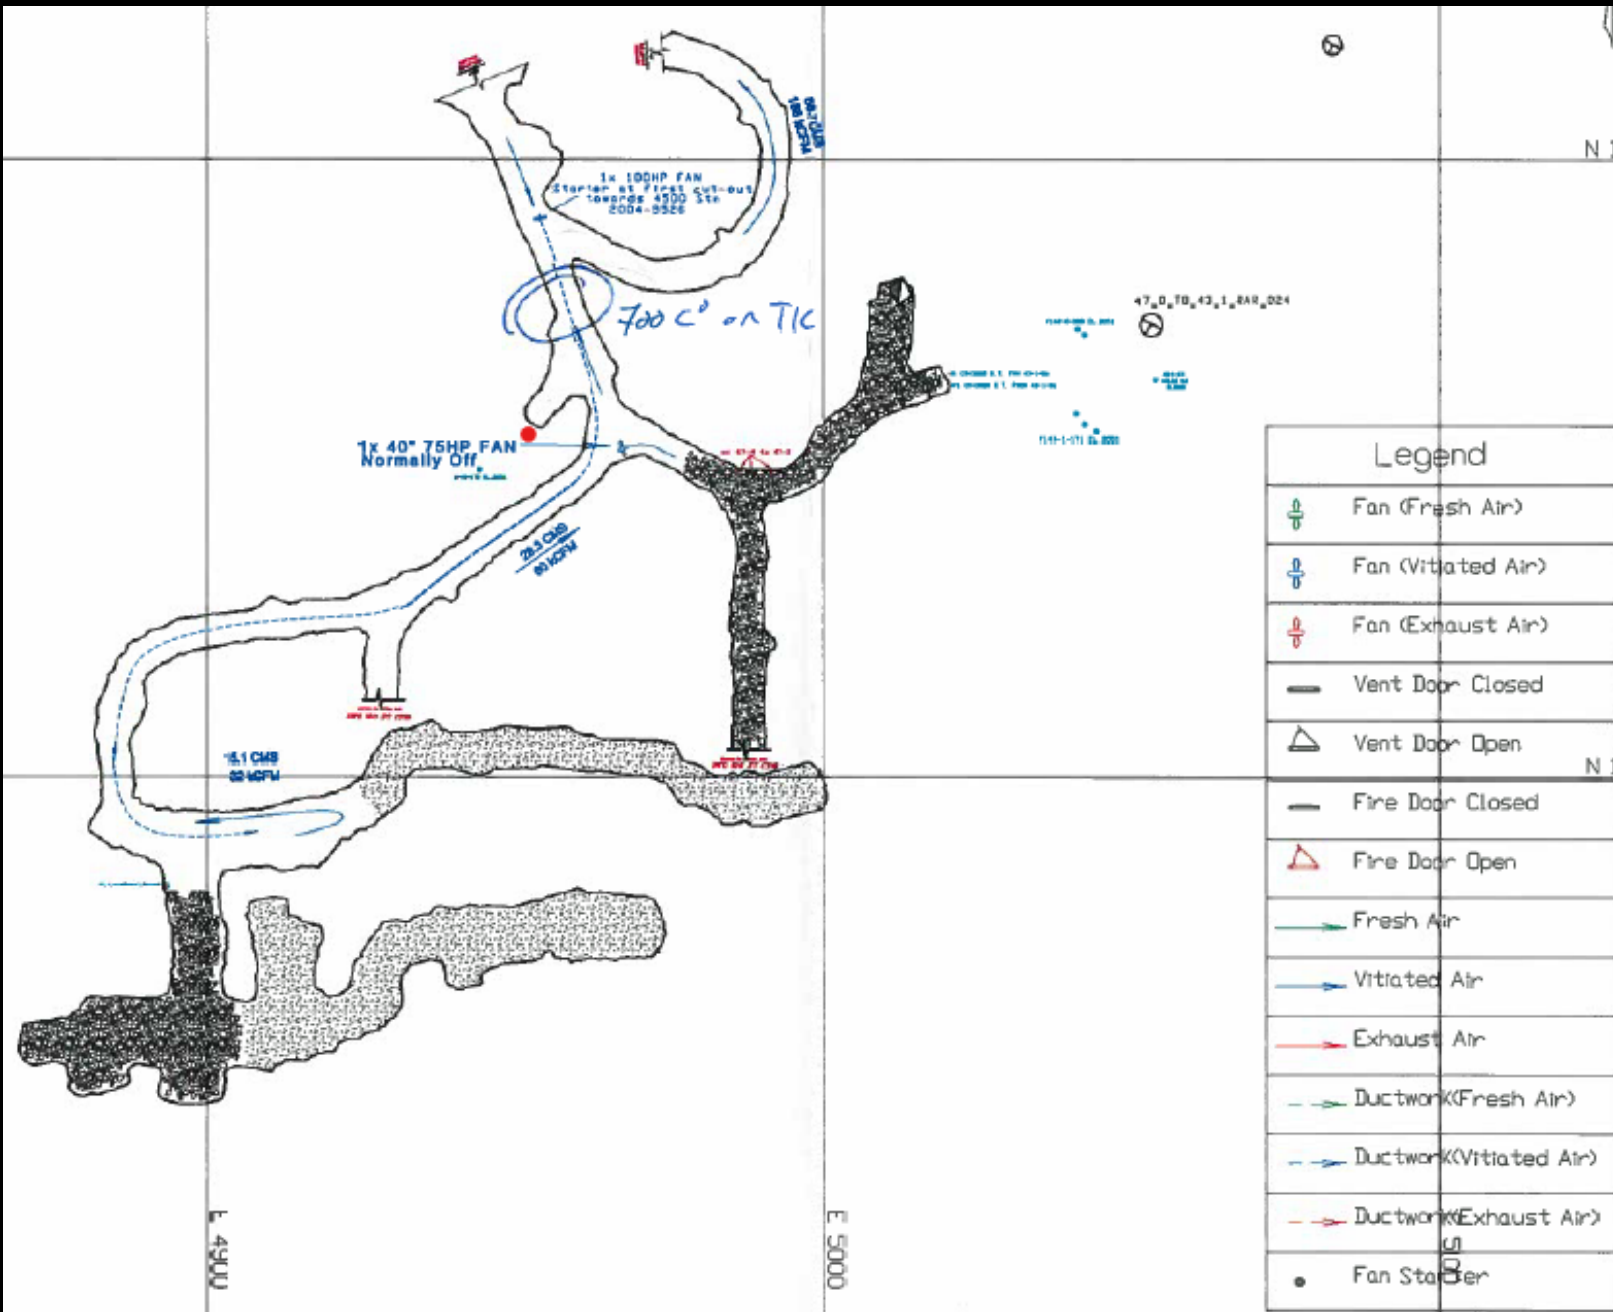
Jul 7, 2020 8:00:57 AM

- Emergency procedures were implemented soon after
- Team #1 went underground at around 0100 hrs and encountered the fire scene at 01:55 hrs.
- Dark black smoke and extreme heat were encountered at the area. (700F recorded with TIC)
- Communication was affected and could not be established at the work site.
